Environmental Permit No.: EP-451/2013
Environmental Team for Trunk Road T2

Appendix M – Summary of Exceedance

Reporting Month: October 2022

- Notification of Exceedances

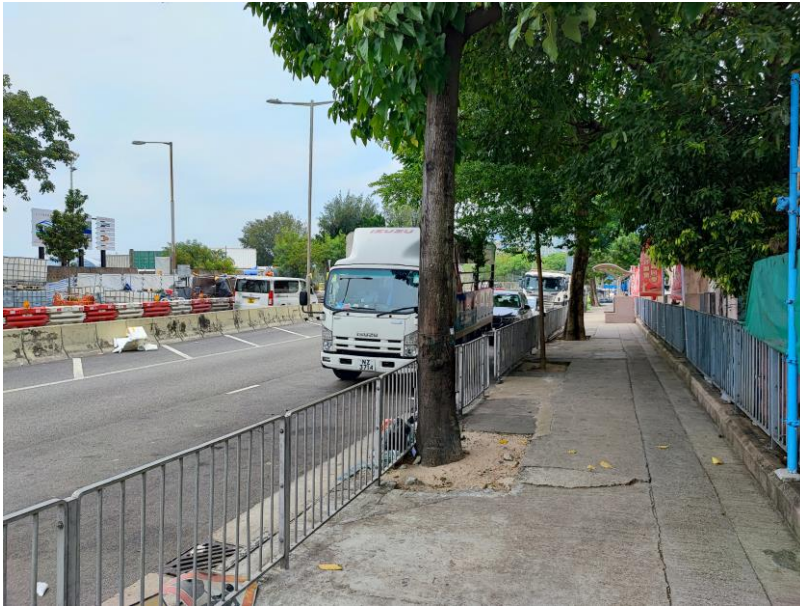
Photo 1

<p>(a) Statement of exceedance(s)</p> <p>24-hour TSP monitoring measured at CKL2 on 17 October 2022 exceeded the action level.</p>
<p>(b) Cause of exceedance(s)</p> <p>According to the observation of our field staff and the information provided by ER and Contractor, the major dust source(s) and/or reason(s) for exceedance identified at CKL1 is/are as follow:</p> <ol style="list-style-type: none"> 1. No major project related construction activity was observed during monitoring at CKL2. However, it observed that construction work of DSD was being conducted along the Cha Kwo Ling Road. (See Photo 1) 2. Fluctuation of road traffic along the Cha Kwo Ling Road. (Photo 2)

Based on the finding(s) and observation(s) above, we deduce the Action Level exceedance of 24-hour TSP recorded at station CKL2 on 17 October 2022 is due to fluctuation of road traffic and the construction activity from DSD, therefore, the exceedance is considered as **non-project related**.

Although the exceedance is considered as non-project related, contractor is reminded that the following construction dust mitigation measures shall always to be implemented on site to reduce/ minimize the generation of dust due to the construction activities.

1. Watering of the construction areas 12 times per day to reduce dust emissions.
2. Side enclosure and covering of any aggregate or dusty material storage piles to reduce emissions.
3. Open stockpiles shall be avoided or covered.
4. Tarpaulin covering of all dusty vehicle loads transported to, from and between site locations.
5. Establishment and use of vehicle wheel and body washing facilities at the exit points of the site.
6. Imposition of speed controls for vehicles on unpaved site roads, 8 km per hour is the recommended limit.
7. Use of regular watering to reduce dust emissions from exposed site surfaces and unpaved roads, particularly during dry weather.

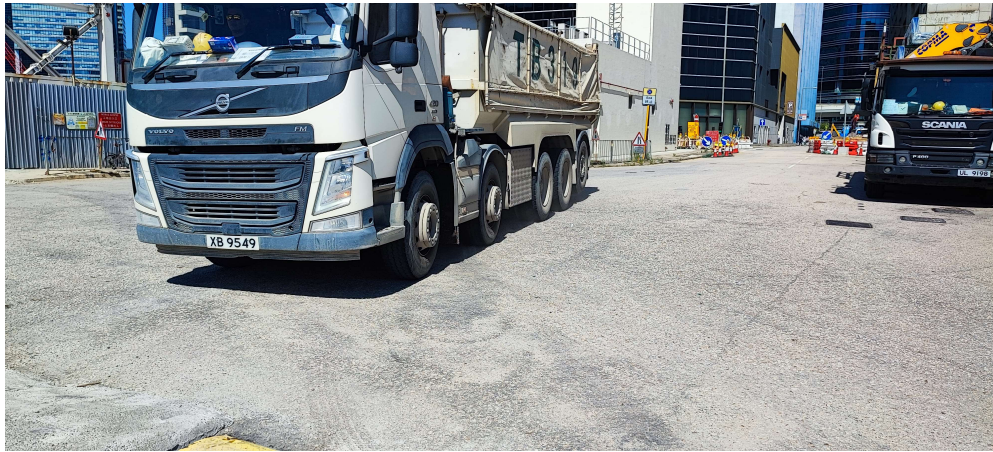
Photo 1

<p>(a) Statement of exceedance(s) 24-hour TSP monitoring measured at KER1 on 17 October 2022 exceeded the Limit level.</p>
<p>(b) Cause of exceedance(s) According to the observation of our field staff, the major dust source(s) and/or reason(s) for exceedance identified at KER1 is/are as follow:</p> <ol style="list-style-type: none"> 1. Observable dust sources, such as wind erosion, loading and unloading of material, and vehicle movement on site, were identified. (See Photo 1) 2. Dust reduction measure, i.e. Wheel washing facility was observed and operated normally. (See Photo 2). However, sand and tiny gravel were observed at the site entrance. (See Photo 3)

The following construction dust mitigation measures shall always to be implemented on site to reduce/ minimize the generation of dust due to the construction activities.

1. Watering of the construction areas 12 times per day to reduce dust emissions.
2. Side enclosure and covering of any aggregate or dusty material storage piles to reduce emissions.
3. Open stockpiles shall be avoided or covered.
4. Tarpaulin covering of all dusty vehicle loads transported to, from and between site locations
5. Establishment and use of vehicle wheel and body washing facilities at the exit points of the site.
6. Imposition of speed controls for vehicles on unpaved site roads, 8 km per hour is the recommended limit
- 7.

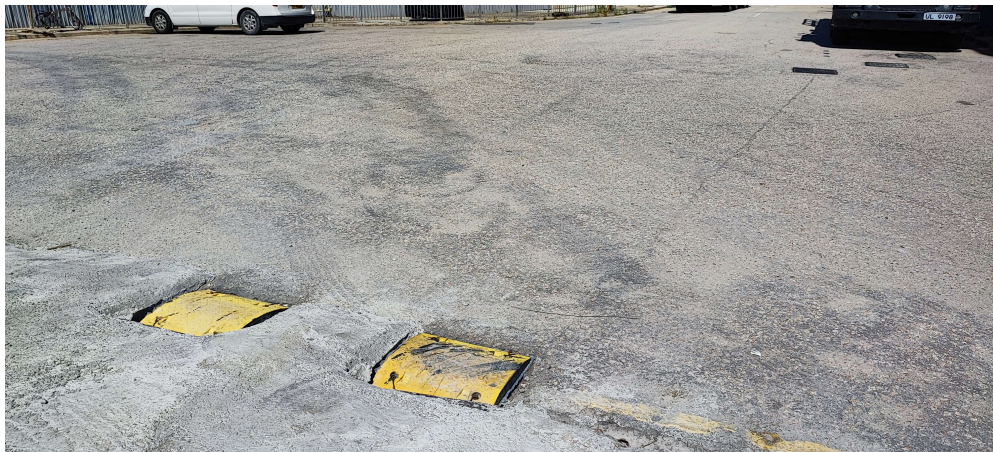
Photo 3

Based on the finding(s) and observation(s) above, we deduce the Limit Level exceedance of 24-hour TSP recorded at station KER1 on 17 October 2022 is due to the insufficient dust reduction measure was carried out to reduce emissions (i.e watering in the site entrance). Therefore, the exceedance is considered as **project related**.

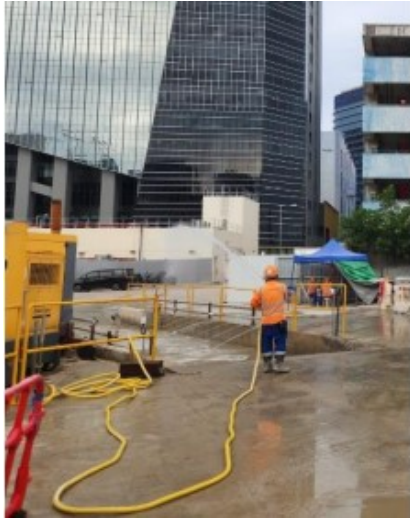
Photo 4 – Wheel Washing Facilities

2. The remedial measures proposed by the contractor was reviewed during site audit and ET has no adverse comments on the proposed remedial measures. The photo records provided by contractor are shown as below:

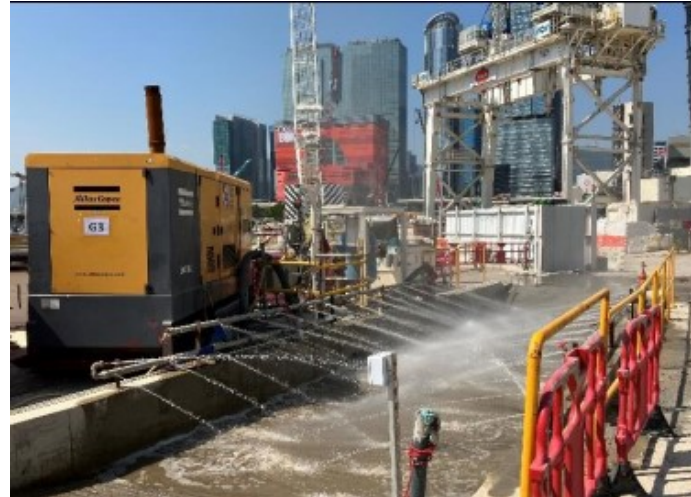
Photo 5 – Wheel Washing Facilities

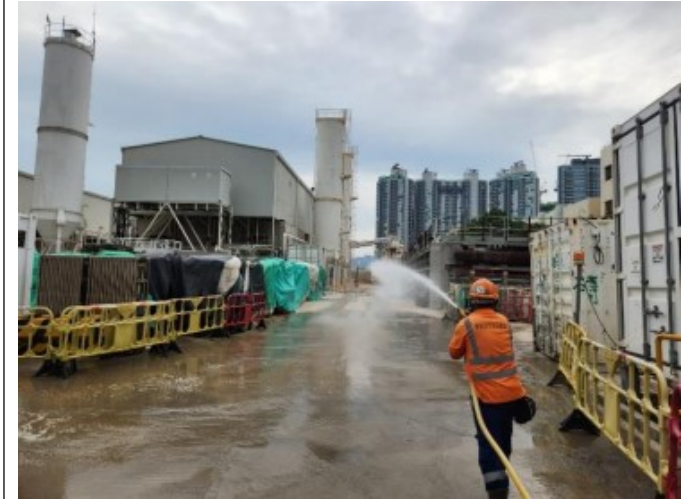
Photo 6 – Watering on the main haul road

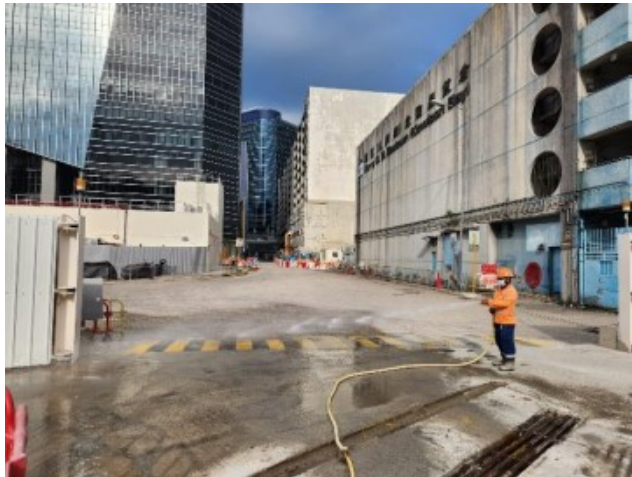
Photo 7 – Watering at the site entrance

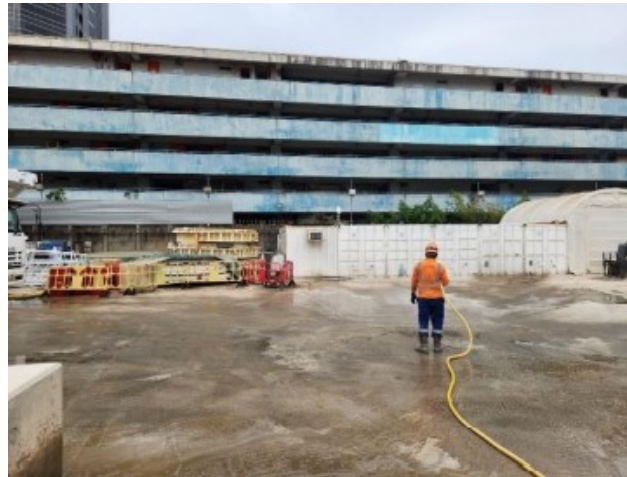
Photo 8 – Watering on the main haul road

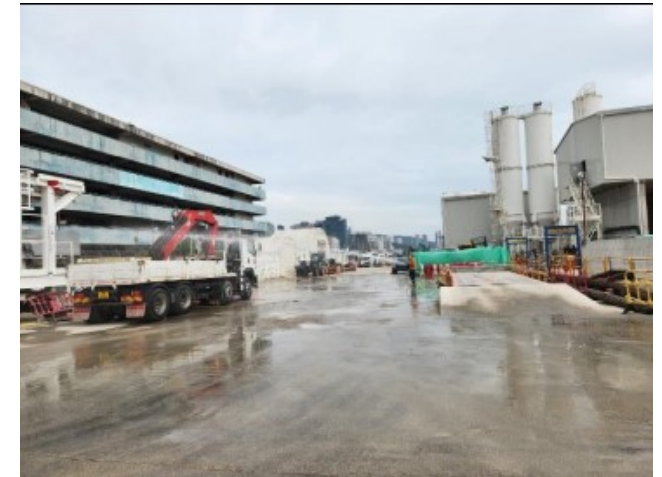
Photo 10 – Watering on the main haul road

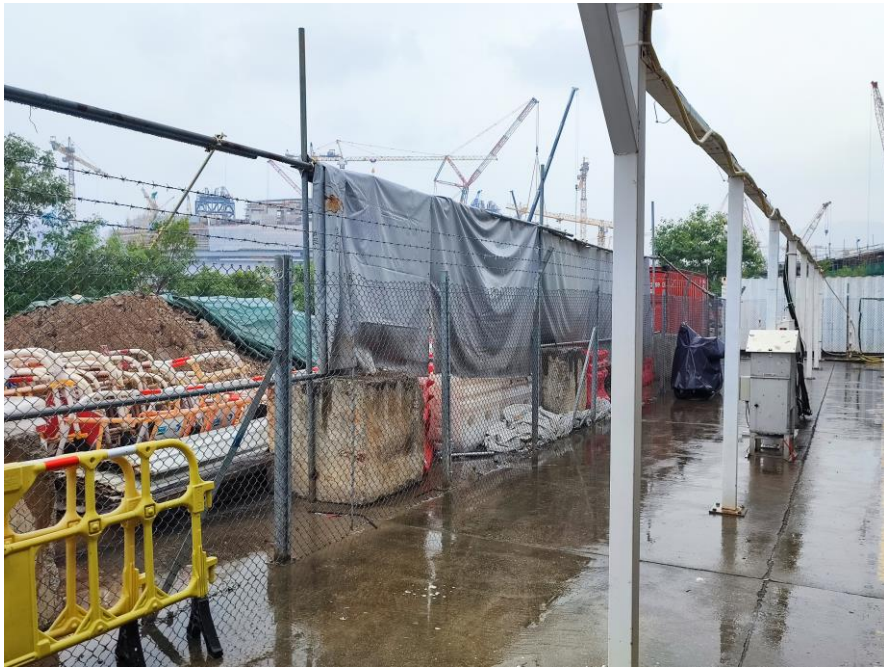
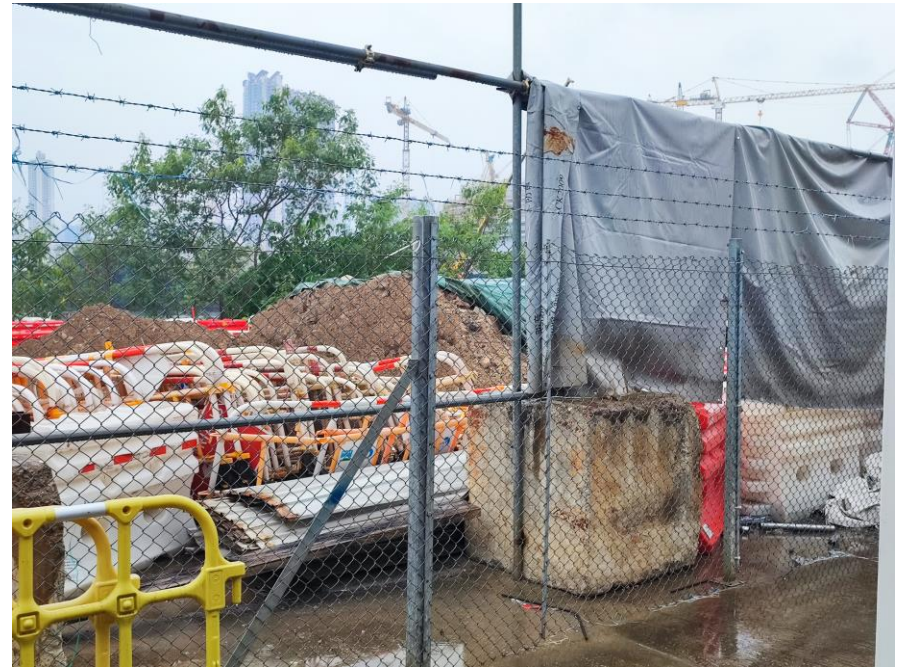
<p>(a) Statement of exceedance(s) 24-hour TSP monitoring measured at KTD2d on 17 October 2022 exceeded the Limit level.</p>
<p>(b) Cause of exceedance(s) According to the observation of our field staff, the major dust source(s) and/or reason(s) for exceedance identified at KTD2d is/are as follow:</p> <ol style="list-style-type: none"> It observed that a stockpile of excavated dusty material with impervious sheet was not covered thoroughly from the construction site which does not belong to BTP. (See Photo 1&2)

Based on the finding(s) and observation(s) above, we deduce the Limit Level exceedance of 24-hour TSP recorded at station KTD2d on 17 October 2022 is due to the construction activities which does not belong to BTP Therefore, the exceedance is considered as **non-project related**.

The following construction dust mitigation measures shall always to be implemented on site to reduce/ minimize the generation of dust due to the construction activities.

1. Watering of the construction areas 12 times per day to reduce dust emissions.
2. Side enclosure and covering of any aggregate or dusty material storage piles to reduce emissions.
3. Open stockpiles shall be avoided or covered.
4. Tarpaulin covering of all dusty vehicle loads transported to, from and between site locations
5. Establishment and use of vehicle wheel and body washing facilities at the exit points of the site.
6. Imposition of speed controls for vehicles on unpaved site roads, 8 km per hour is the recommended limit

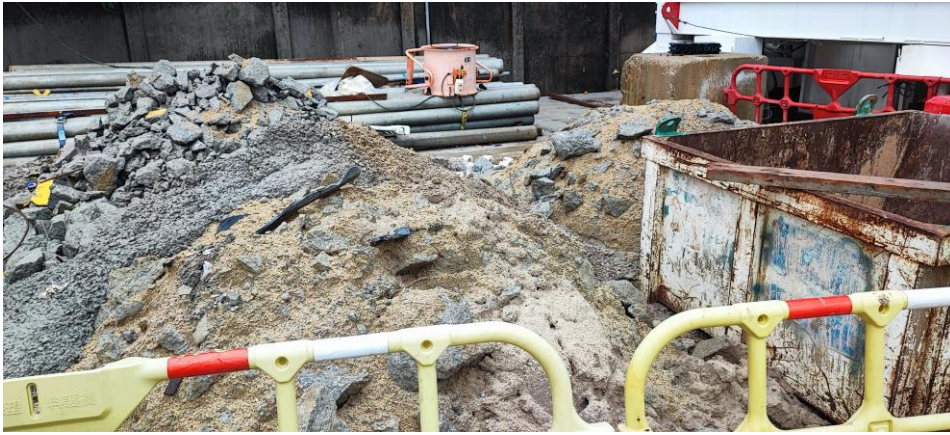
Photo 1

<p>(a) Statement of exceedance(s) 24-hour TSP monitoring measured at KER1 on 22 October 2022 exceeded the Action level.</p>
<p>(b) Cause of exceedance(s) According to the observation of our field staff and the site audit on 3 November 2022, the major dust source(s) and/or reason(s) for exceedance identified at KER1 is/are as follow:</p> <ol style="list-style-type: none"> 1. The open stockpiles were not covered with impervious materials which closed with the HVS. (See Photo 1) 2. Dry weather 3. Observable dust sources, such as wind erosion, loading and unloading of material, and vehicle movement on site, were identified. (See Photo 2)

Based on the finding(s) and observation(s) above, we deduce the Action Level exceedance of 24-hour TSP recorded at station KER1 on 22 October 2022 is due to the uncovered stockpiles which was very close to the HVS. Therefore, the exceedance is considered as **project related**.

The following construction dust mitigation measures shall always to be implemented on site to reduce/ minimize the generation of dust due to the construction activities.

1. Watering of the construction areas 12 times per day to reduce dust emissions.
2. Side enclosure and covering of any aggregate or dusty material storage piles to reduce emissions.
3. Open stockpiles shall be avoided or covered.
4. Tarpaulin covering of all dusty vehicle loads transported to, from and between site locations
5. Establishment and use of vehicle wheel and body washing facilities at the exit points of the site.
6. Imposition of speed controls for vehicles on unpaved site roads, 8 km per hour is the recommended limit

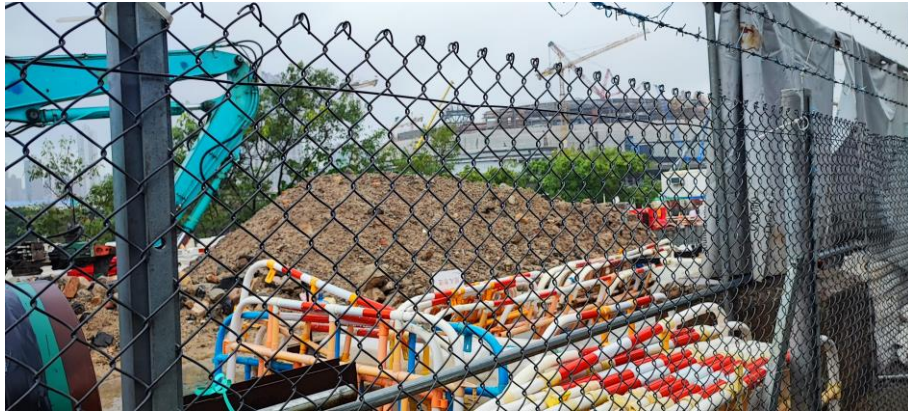
Photo 1

<p>(a) Statement of exceedance(s) 24-hour TSP monitoring measured at KTD2d on 22 October 2022 exceeded the Action level.</p>
<p>(b) Cause of exceedance(s) According to the observation of our field staff and the site audit on 3 November 2022, the major dust source(s) and/or reason(s) for exceedance identified at KER1 is/are as follow:</p> <ol style="list-style-type: none"> 1. It observed that a stockpile of excavated dusty material with impervious sheet was not covered thoroughly from the construction site which did not belong to BTP. (See Photo 1) 2. Dry weather 3. The loading and unloading of material and vehicle movement were observed from the construction site which did not belong to BTP (See Photo 2)

Based on the finding(s) and observation(s) above, we deduce the Action Level exceedance of 24-hour TSP recorded at station KTD2d on 22 October 2022 is due to the construction activities which does not belong to BTP Therefore, the exceedance is considered as **non-project related**.

The following construction dust mitigation measures shall always to be implemented on site to reduce/ minimize the generation of dust due to the construction activities.

1. Watering of the construction areas 12 times per day to reduce dust emissions.
2. Side enclosure and covering of any aggregate or dusty material storage piles to reduce emissions.
3. Open stockpiles shall be avoided or covered.
4. Tarpaulin covering of all dusty vehicle loads transported to, from and between site locations
5. Establishment and use of vehicle wheel and body washing facilities at the exit points of the site.
6. Imposition of speed controls for vehicles on unpaved site roads, 8 km per hour is the recommended limit

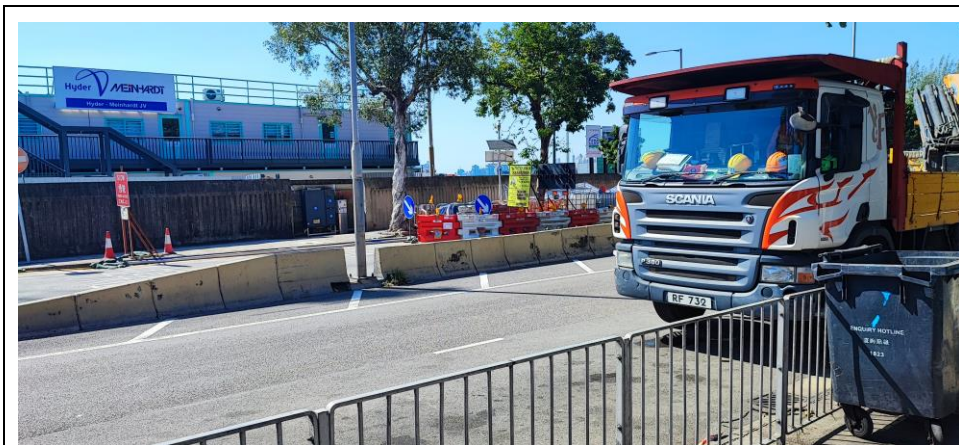
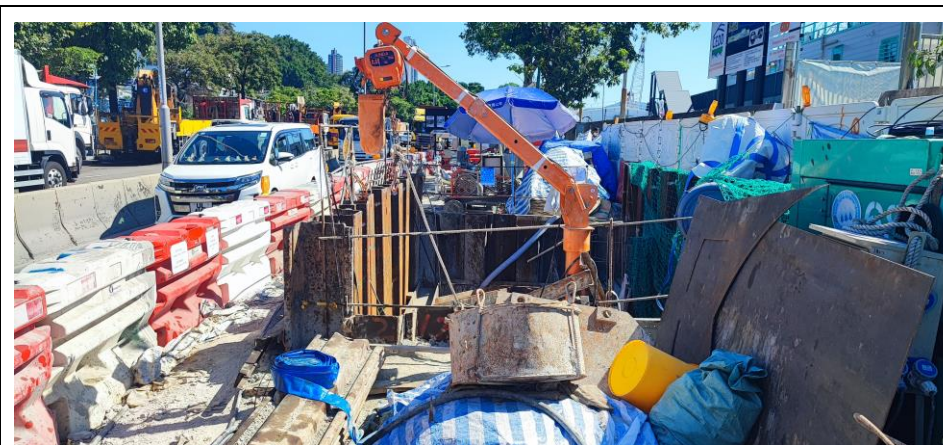
<p>(a) Statement of exceedance(s)</p> <p>24-hour TSP monitoring measured at CKL1 on 27 October 2022 exceeded the action level.</p>
<p>(b) Cause of exceedance(s)</p> <p>According to the observation of our field staff and the information provided by ER and Contractor, the major dust source(s) and/or reason(s) for exceedance identified at CKL1 is/are as follow:</p> <ol style="list-style-type: none"> 1. No major project related construction activity was observed during monitoring at CKL1. However, it observed that construction work of DSD was being conducted along the Cha Kwo Ling Road (See Photo 1-2). 2. Fluctuation of road traffic along the Cha Kwo Ling Road.

Based on the finding(s) and observation(s) above, we deduce the Action Level exceedance of 24-hour TSP recorded at station CKL1 on 27 October 2022 is due to fluctuation of road traffic and the construction activity from DSD, therefore, the exceedance is considered as **non-project related**.

Although the exceedance is considered as non-project related, contractor is reminded that the following construction dust mitigation measures shall always to be implemented on site to reduce/ minimize the generation of dust due to the construction activities.

1. Watering of the construction areas 12 times per day to reduce dust emissions.
2. Side enclosure and covering of any aggregate or dusty material storage piles to reduce emissions.
3. Open stockpiles shall be avoided or covered.
4. Tarpaulin covering of all dusty vehicle loads transported to, from and between site locations.
5. Establishment and use of vehicle wheel and body washing facilities at the exit points of the site.
6. Imposition of speed controls for vehicles on unpaved site roads, 8 km per hour is the recommended limit.
7. Use of regular watering to reduce dust emissions from exposed site surfaces and unpaved roads, particularly during dry weather.
