## Contract No. ED/2018/04

Trunk Road T2 and Infrastructure Works for Developments at the Former South Apron

# **Appendix I – Summary of Exceedance**

## Reporting Quarter: May 2021 - July 2021

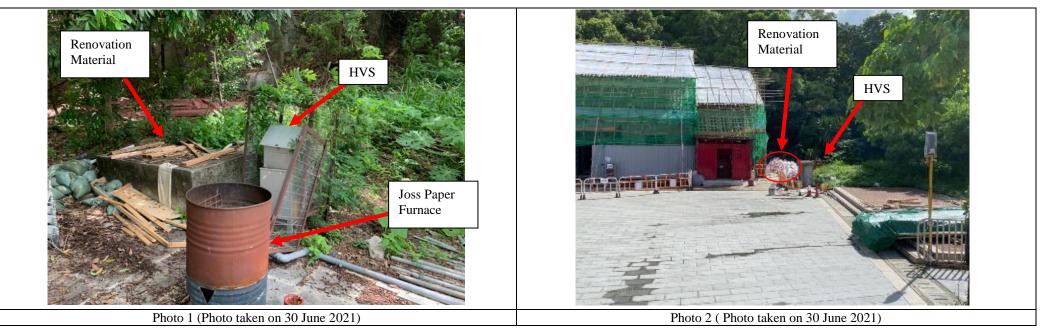
Photo Record (Photo Taken by ET)

(	a) Statement of exceedance(s)						
	24-hour TSP monitoring measured at AM1 on 30 June 2021 exceeded the limit level.						
(	b) Cause of exceedance(s)						
	According to the observation of our field staff, the major dust source(s) and/or reason(s) for exceedance identified at AM1 is/are as follow:						
	1. Renovation of Tin Hau Temple began in mid-May 2021.						
	2. Piles of renovation material were scattered around Tin Hau Temple during the monitoring period (See Photo 1 and 2). Frequent material transportation may cause dust nuisance to the surrounding.						
	3. Joss paper furnace was found right next to the HVS, which may affect the result if incense burning was conducted.						
	4. Non-project related construction works (TKOLTT project)

- 5. Road traffic along Cha Kwo Ling Road
- 6. RE and Contractor have confirmed that no construction activity was carried out in the vicinity of the Tin Hau Temple on 30 June 2021 1 July 2021 under this contract.

Based on the finding(s) and observation(s) above, we deduce the limit Level exceedance of 24-hour TSP recorded at station AM1 on 30 June 2021 is due to the non-project related influence. Therefore, the exceedance is considered as **non-project related**.

Although the exceedance is consider as non-project related, it is recommended that the following construction dust mitigation measures shall always to be implemented on site to reduce/ minimize the generation of dust due to the construction activities.

- 1. Watering of the construction areas 12 times per day to reduce dust emissions.
- 2. Side enclosure and covering of any aggregate or dusty material storage piles to reduce emissions.
- 3. Open stockpiles shall be avoided or covered.
- 4. Tarpaulin covering of all dusty vehicle loads transported to, from and between site locations.
- 5. Establishment and use of vehicle wheel and body washing facilities at the exit points of the site.
- 6. Imposition of speed controls for vehicles on unpaved site roads, 8 km per hour is the recommended limit.
- 7. Use of regular watering to reduce dust emissions from exposed site surfaces and unpaved roads, particularly during dry weather.

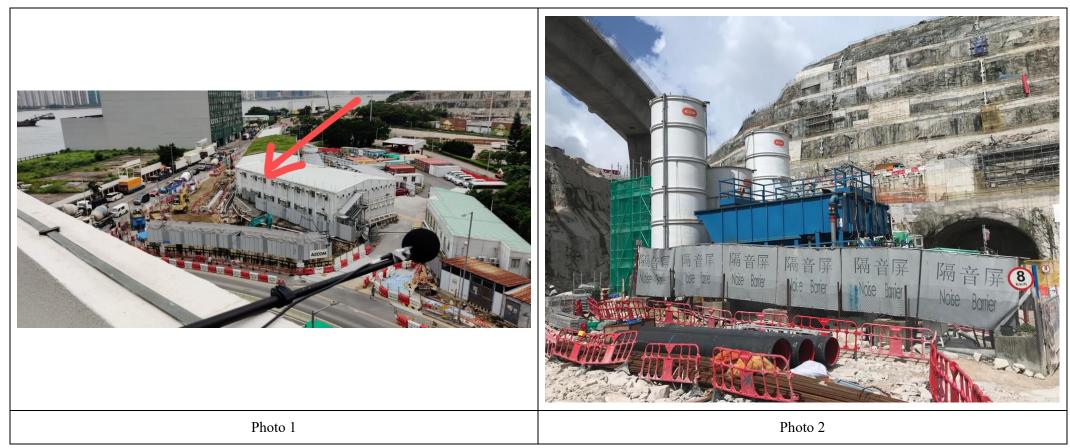
Photo Record (Photo Taken by ET)

- 1. During both first time and repeated measurement, our field staff observed that breaking activity was carried out continuously on the site of TKOLTT. The noise generated by the breaker during breaking activity dominates the ambient or background noise. (See Photo 1)
- 2. Road traffic along Yau Tong Road.
- 3. Noise barriers were erected on the site of TKOLTT.
- 4. Noise barriers were erected on the site of Trunk Road T2.

Based on the finding(s) and observation(s) above, the limit level exceedance of construction noise recorded at station CM5 on 22 June 2021 was due to the construction activities of the TKOLTT project. Therefore, the exceedance is considered as **non-project related**.

Although the exceedance is considered as non-project related, it is recommended that the following construction noise mitigation measures shall always be implemented on site to reduce/ minimize the construction noise nuisance due to the construction activities.

- 1. Use of temporary or fixed noise barriers with a surface density of at least 10kg/m2 to screen noise from movable and stationary plant;
- 2. Use of acoustic fabric for the silent piling system, drill rigs, rock drills etc;
- 3. Only well-maintained plant should be operated on-site and plants should be serviced regularly during the construction period;
- 4. Mobile plant, if any, should be sited as far from NSRs as possible;
- 5. Use of site hoarding as a noise barrier to screen noise at low level NSRs;
- 6. Machines and plant that may be in intermittent use should be shut down between works periods or should be throttled down to a minimum; and
- 7. Any material stockpiles and other structures should be effectively utilized, wherever practicable, to screen the noise from on-site construction activities.
