Contract No. ED/2018/04

Trunk Road T2 and Infrastructure Works for Developments at the Former South Apron

Appendix I – Summary of Exceedance

Reporting Quarter: August 2021 - October 2021

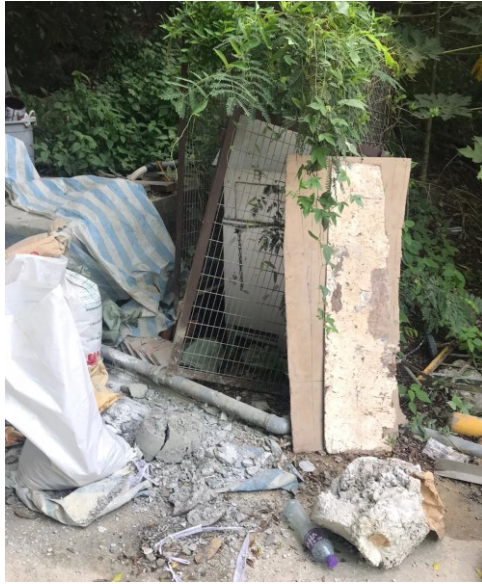
<p>(a) Statement of exceedance(s) 24-hour TSP monitoring measured at AM1 on 15 and 28 September 2021 exceeded the limit and action level respectively.</p>
<p>(b) Cause of exceedance(s) According to the observation of our field staff, the major dust source(s) and/or reason(s) for exceedance identified at AM1 is/are as follow:</p> <ol style="list-style-type: none"> 1. Renovation of Tin Hau Temple began in mid-May 2021. 2. According to our field observation, piles of renovation material were scattered around Tin Hau Temple during the monitoring period (see the photo record). Frequent material transportation may cause dust nuisance to the surrounding 3. Dust generating activities (cement mixing) by renovation staff was observed on-site 4. Joss paper furnace was found right next to the HVS, which may affect the result if incense burning was conducted. 5. Non-project related construction works (TKOLTT project) 6. Road traffic along Cha Kwo Ling Road 7. RE and Contractor have confirmed that no construction activity was carried out in the vicinity of the Tin Hau Temple on 15-16 and 28-29 September 2021 under this contract.

Photo 1 – Recent condition of the High Volume Sampler (HVS) at AM1, Tin Hau Temple. Debris and waste were scattered around the HVS (Taken on 29 Sep 2021)

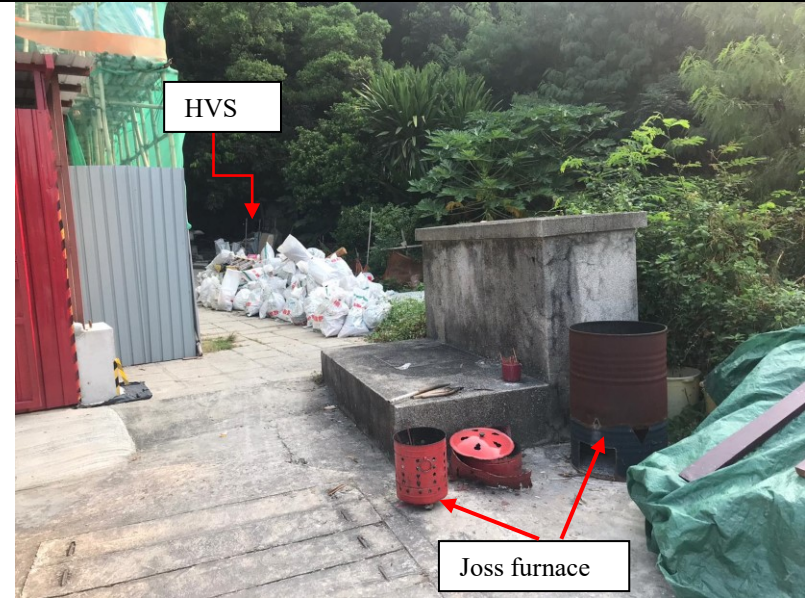
Photo 2 – The HVS was swallowed by bags of dusty materials and the joss furnace located near the HVS. (Taken on 29 Sep 2021)

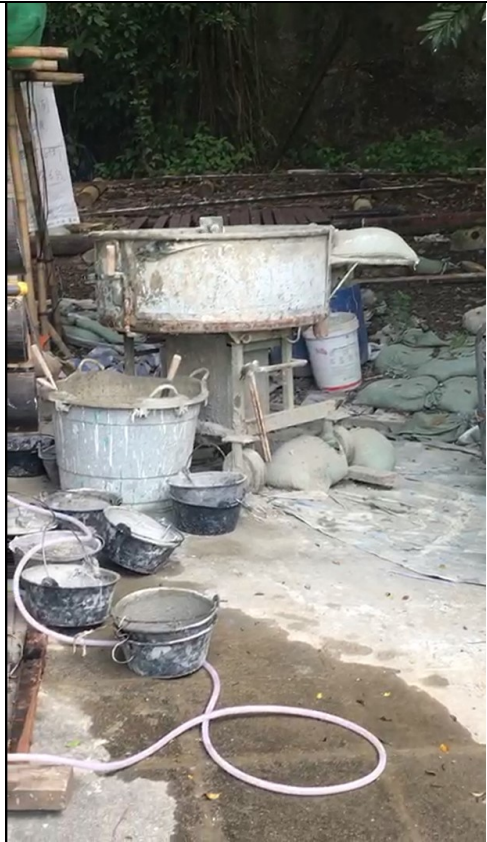
Video Screenshot 1 - Cement mixing carried out by the worker of Temple renovation work

Based on the finding(s) and observation(s) above, we deduce the Limit Level and Action Level exceedance of 24-hour TSP recorded at station AM1 on 15 & 28 September 2021 respectively are due to the non-project related influence. Therefore, the exceedance is considered as **non-project related**.

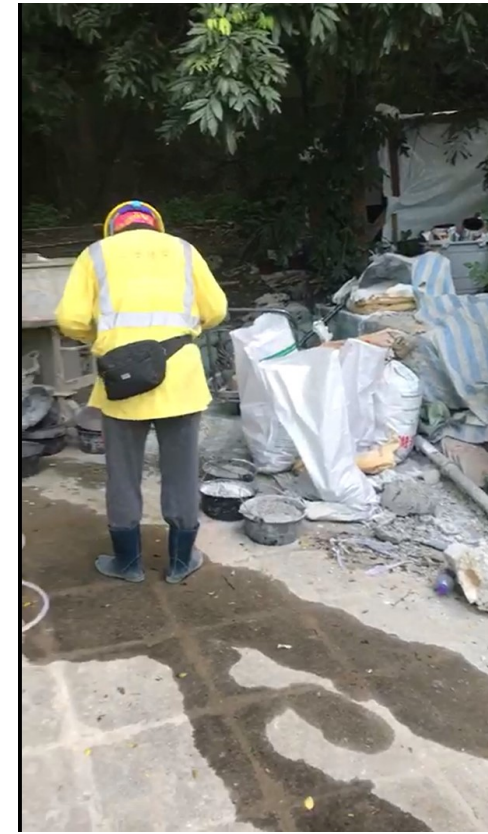
Video Screenshot 2 - Cement mixing carried out by the worker of Temple renovation work
