Contract No. ED/2018/04

Trunk Road T2 and Infrastructure Works for Developments at the Former South Apron

Appendix I – Summary of Exceedance

Reporting Quarter: November 2021 – January 2022

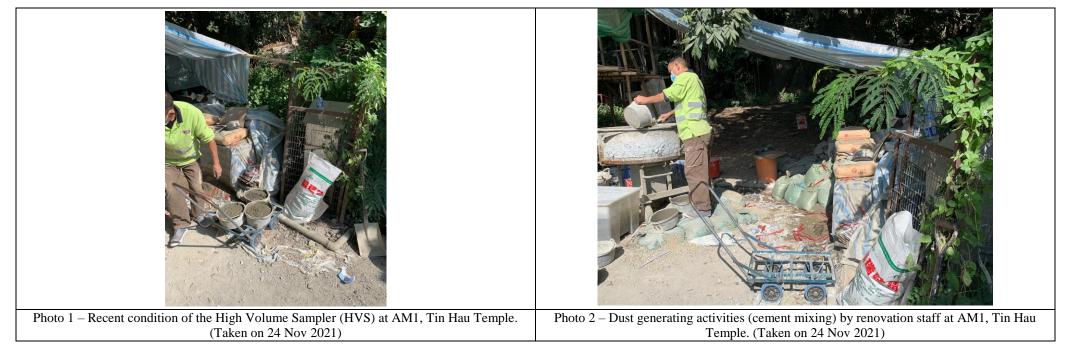
Photo Record (Photo Taken by ET)

- 1. Renovation of Tin Hau Temple began in mid-May 2021.
- 2. According to our field observation, piles of renovation material were scattered around Tin Hau Temple during the monitoring period (see the photo record). Frequent material transportation may cause dust nuisance to the surrounding
- 3. Dust generating activities (cement mixing) by renovation staff was observed on-site
- 4. Joss paper furnace was found right next to the HVS, which may affect the result if incense burning was conducted.
- 5. Non-project related construction works (TKOLTT project)
- 6. Road traffic along Cha Kwo Ling Road
- 7. RE and Contractor have confirmed that no construction activity was carried out in the vicinity of the Tin Hau Temple on 04 05, 10 11 and 16 17 November 2021 under this contract.

Based on the finding(s) and observation(s) above, we deduce the Limit Level and Action Level exceedance of 24-hour TSP recorded at station AM1 on 04&10 and 16 November 2021 respectively are due to the non-project related influence. Therefore, the exceedance is considered as **non-project related**.

- 1. Watering of the construction areas 12 times per day to reduce dust emissions.
- 2. Side enclosure and covering of any aggregate or dusty material storage piles to reduce emissions.
- 3. Open stockpiles shall be avoided or covered.
- 4. Tarpaulin covering of all dusty vehicle loads transported to, from and between site locations.
- 5. Establishment and use of vehicle wheel and body washing facilities at the exit points of the site.
- 6. Imposition of speed controls for vehicles on unpaved site roads, 8 km per hour is the recommended limit.
- 7. Use of regular watering to reduce dust emissions from exposed site surfaces and unpaved roads, particularly during dry weather.
