Contract No. ED/2018/04

Trunk Road T2 and Infrastructure Works for Developments at the Former South Apron

Appendix I – Summary of Exceedance

NOE No. 220929_24hrTSP (AM1) **Exceedance Level: Action**

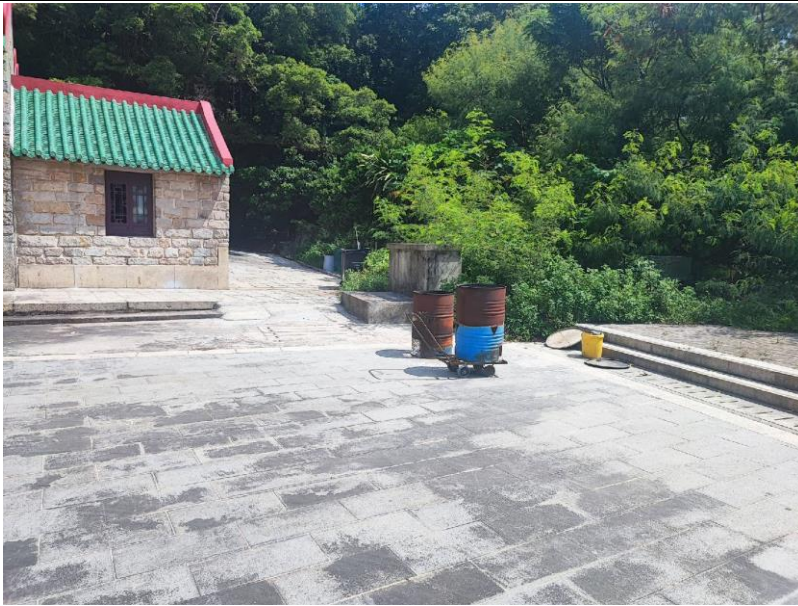
<p>(a) Statement of exceedance(s) 24-hour TSP monitoring measured at AM1 on 29 September 2022 exceeded the action level.</p>
<p>(b) Cause of exceedance(s) According to the observation of our field staff, the major dust source(s) and/or reason(s) for exceedance identified at AM1 is/are as follow:</p> <ol style="list-style-type: none"> 1. According to our field observation, the joss paper furnace was found next to the high volume sampler (HVS), which may affect the result if incense burning was conducted. 2. Non-project related construction works (TKOLTT project) 3. Road traffic along Cha Kwo Ling Road 4. RE and Contractor have confirmed that no construction activity was carried out in the vicinity of the Tin Hau Temple on 29-30 September 2022 under this contract.

Photo 1 – The joss paper furnace was found next to the high volume sampler (HVS) at AM1.
(Taken on 5 Oct 2022)

Based on the finding(s) and observation(s) above, we deduce Action Level exceedance of 24-hour TSP recorded at station AM1 on 29 September 2022 respectively are due to the non-project related influence. Therefore, the exceedance is considered as **non-project related**.

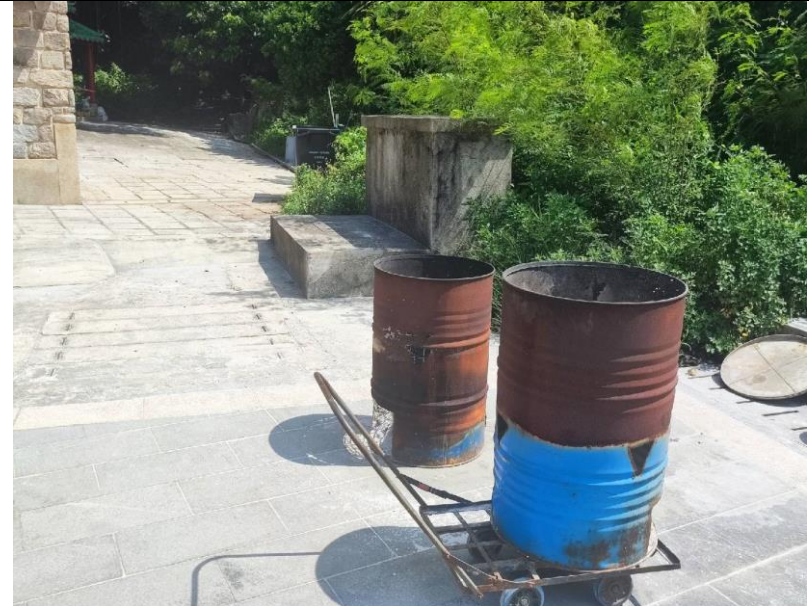
Photo 2 – The joss paper furnace was found next to the high volume sampler (HVS) at AM1.
(Taken on 5 Oct 2022)
