Trunk Road T2 Monthly Environmental Monitoring and Audit Report (under EP-451/2013) March 2023 (Version 1.0)

**Re: Agreement No. EDO 01/2019
Independent Environmental Checker for
Contract No. ED/2018/04 – Trunk Road T2 and Infrastructure Works for
Developments at the Former South Apron**

Monthly EM&A Report (March 2023) for EP-451/2013

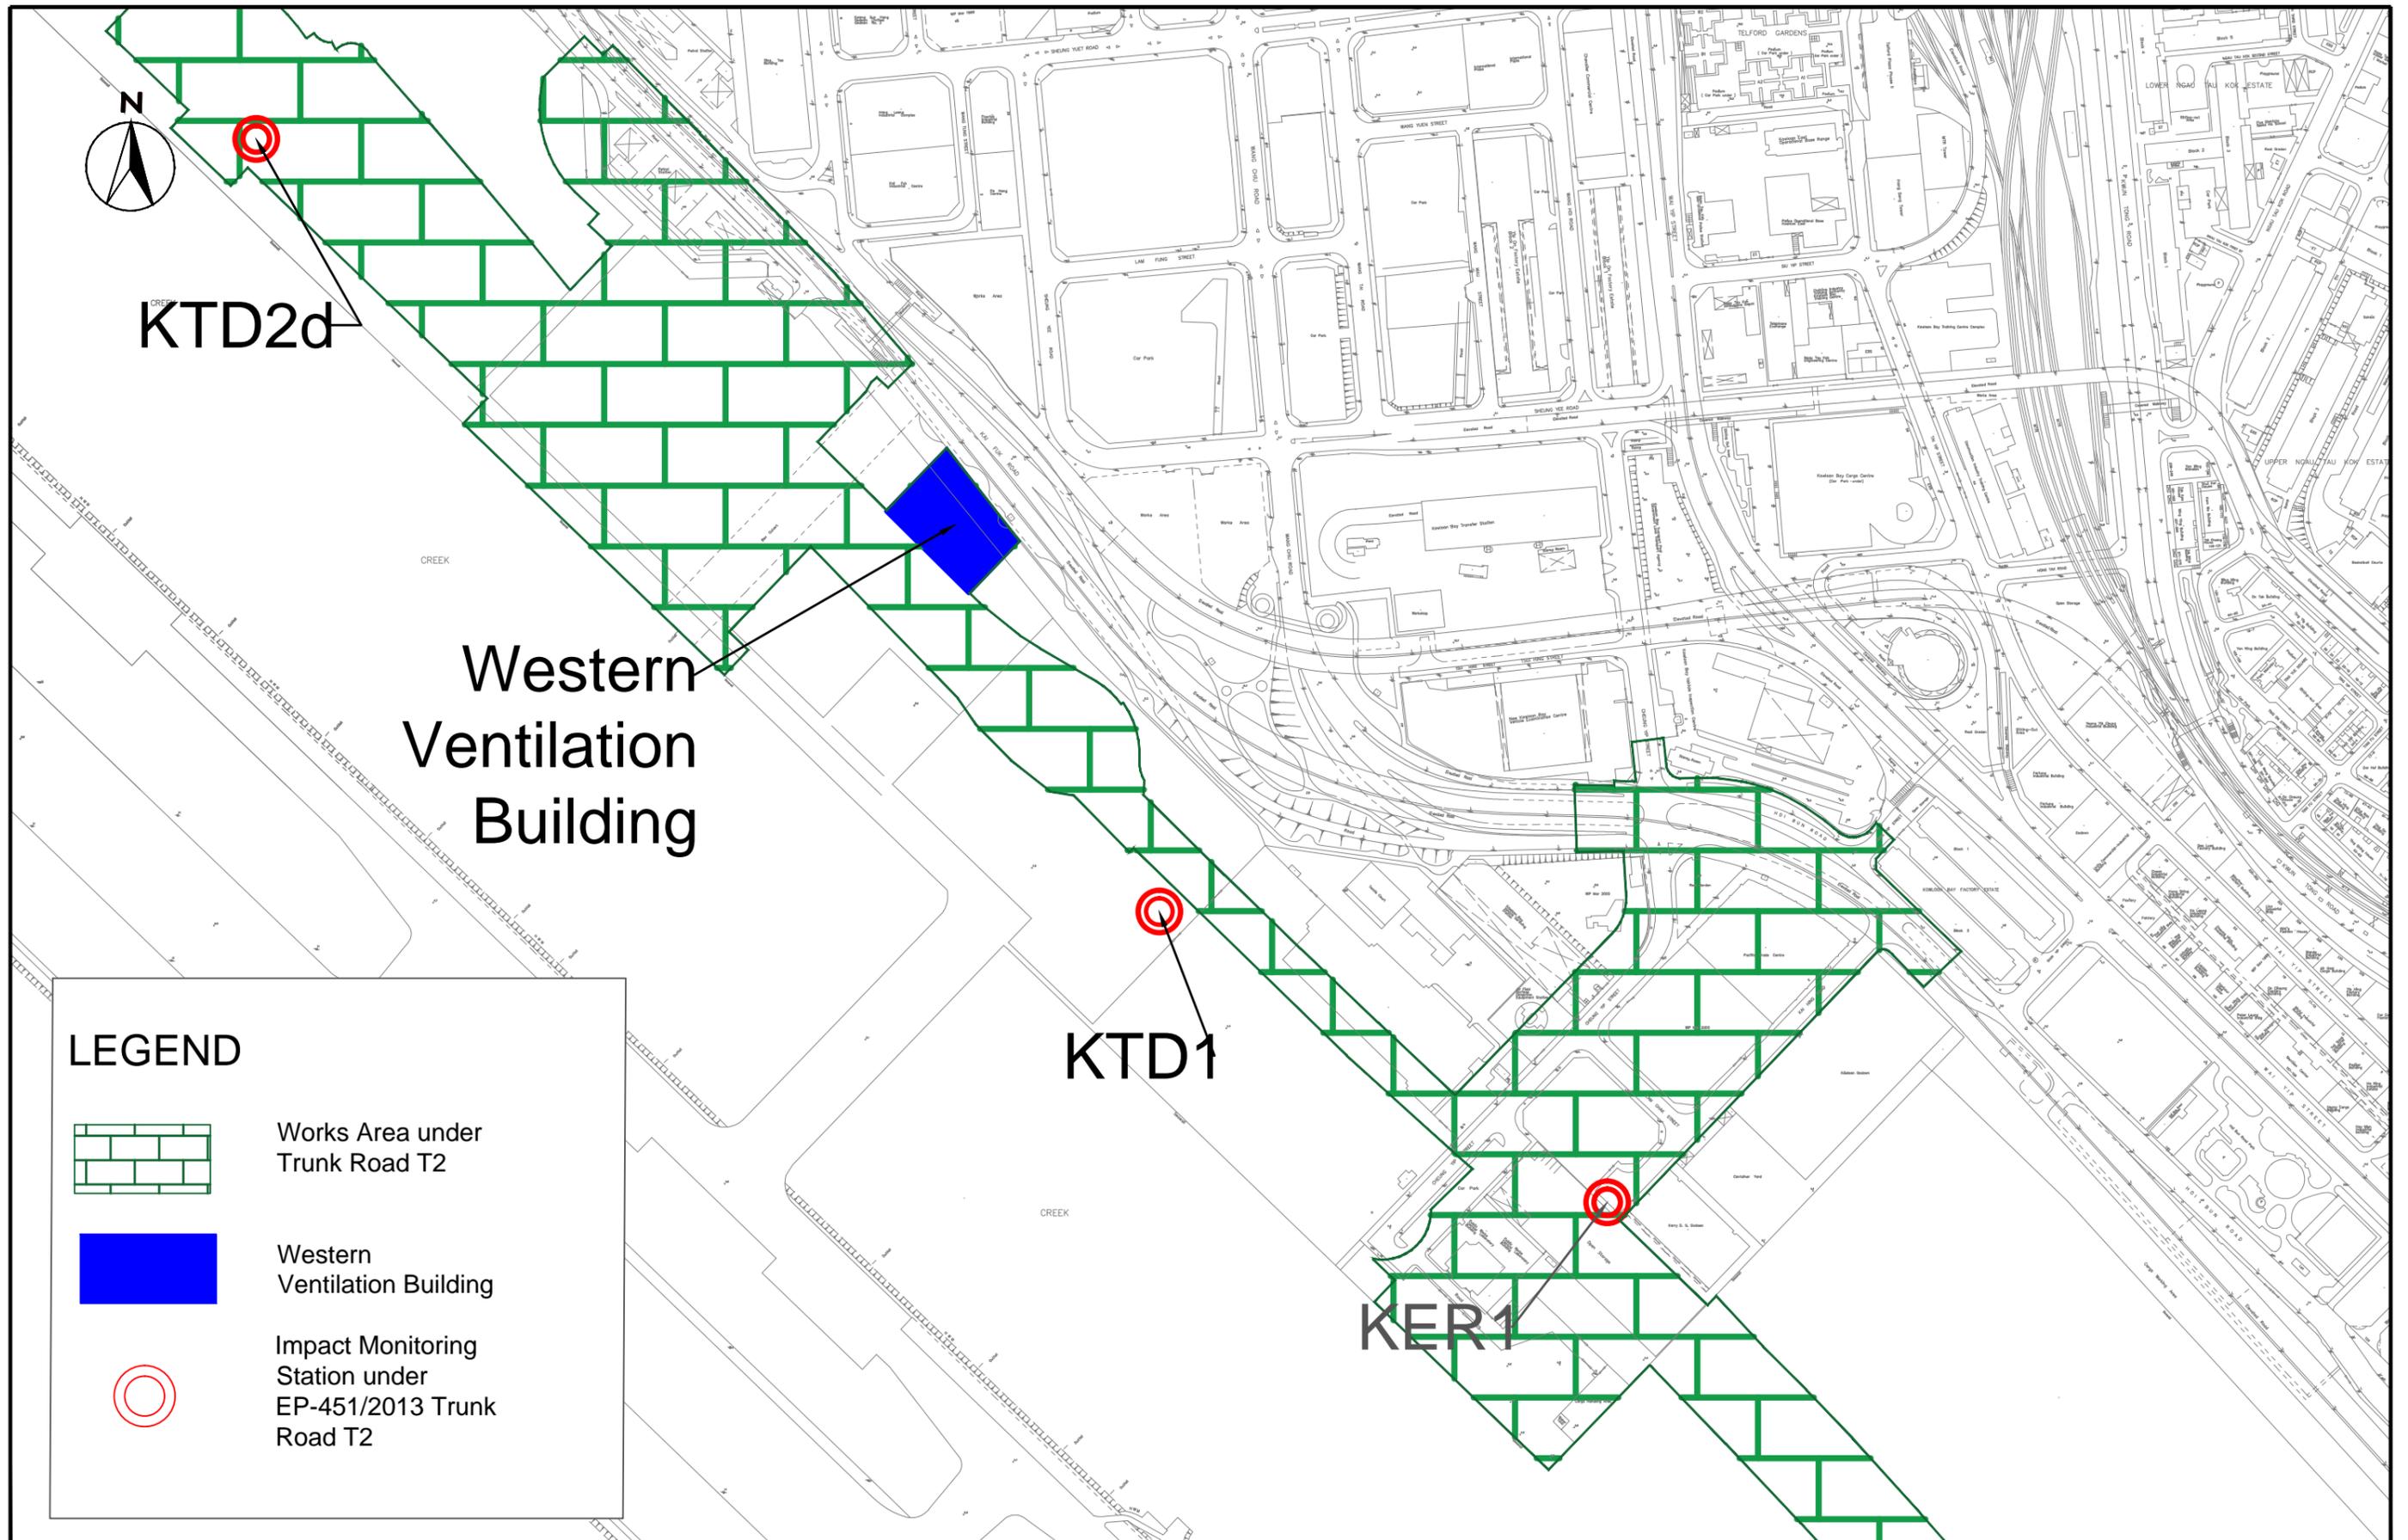
SCALE	1:4000@A3	DATE	Jun 21
CHECK	KC	DRAWN	TL
JOB No.	MA20003	FIGURE No.	Fig 2a
		REV	-

Impact Monitoring Station under EP-451/2013 Trunk Road T2

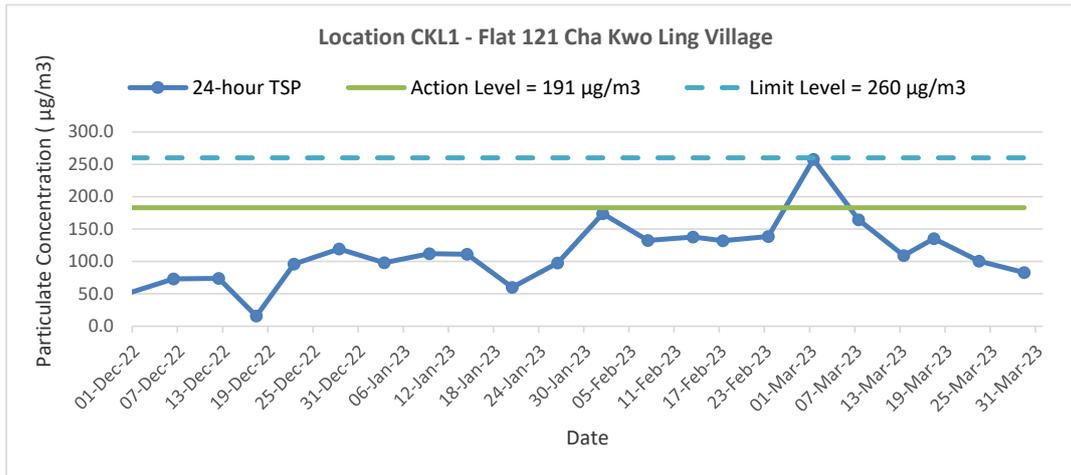
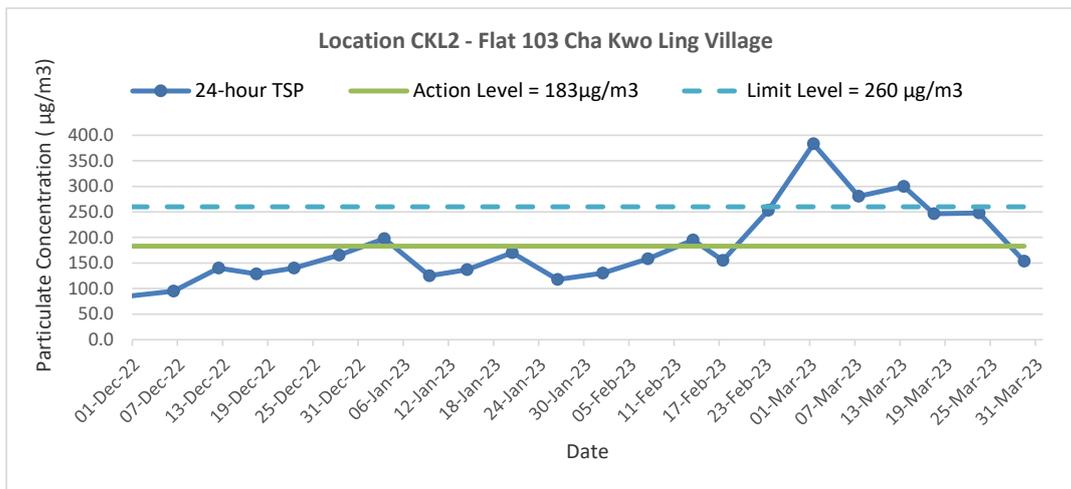
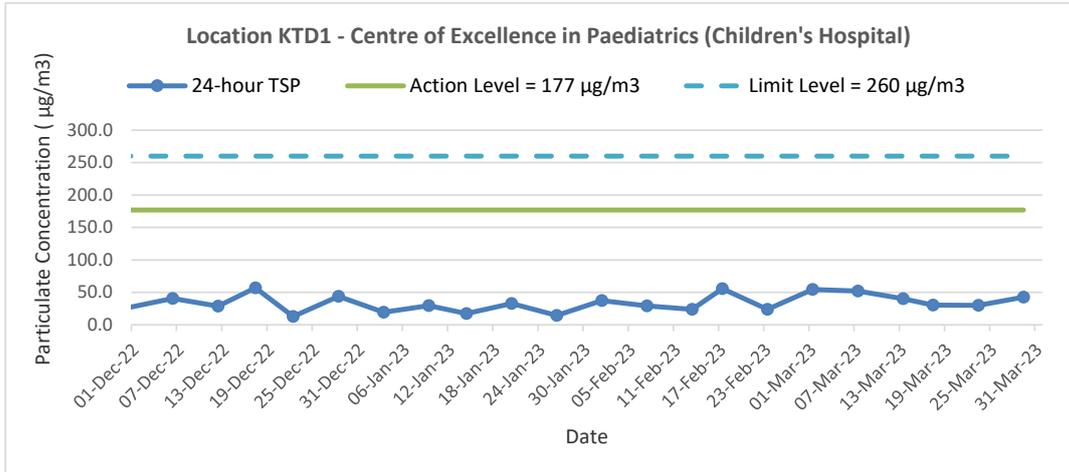
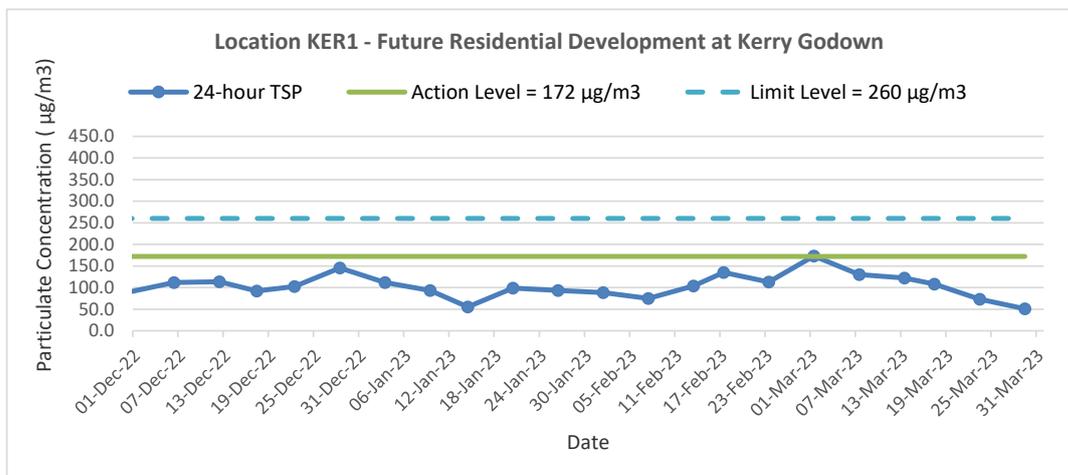
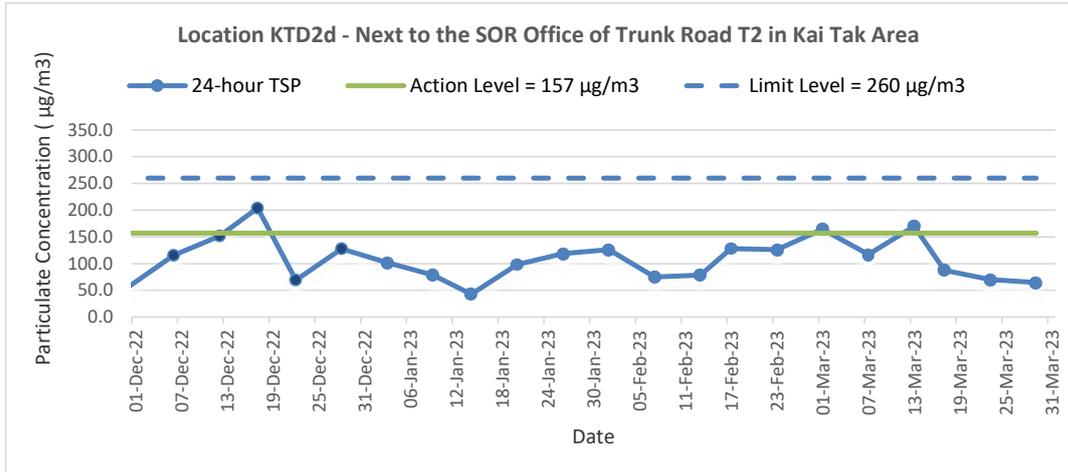
24-hr TSP Concentration Levels

Title Trunk Road T2 and Infrastructure Works for Developments at the Former South Apron Graphical Presentation of 24-hour TSP Monitoring Results	Date Mar-23	Project No. MA20003	
		Appendix F

Title	Trunk Road T2 and Infrastructure Works for Developments at the Former South Apron	Date	Mar-23	Project No.	MA20003	CINOTECH
	Graphical Presentation of 24-hour TSP Monitoring Results			Appendix	F

- 2.17 The monitoring data and graphical presentations of 24-hour TSP monitoring results are shown in **Appendix F**.
- 2.18 According to field observations observed in the reporting period, the major dust source identified at the designated air quality monitoring stations are as follows:

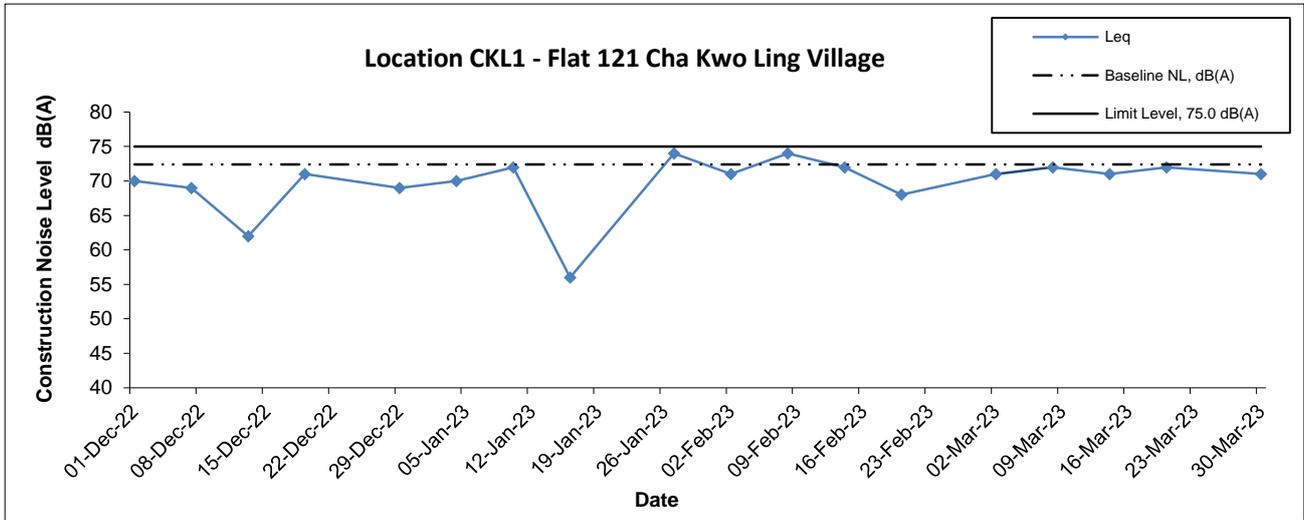
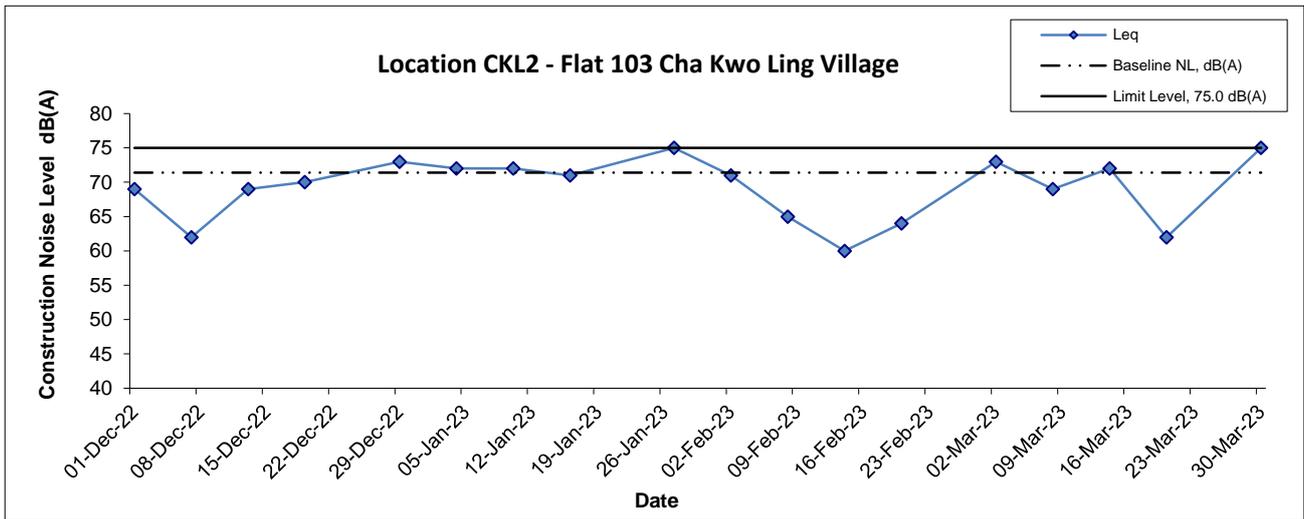
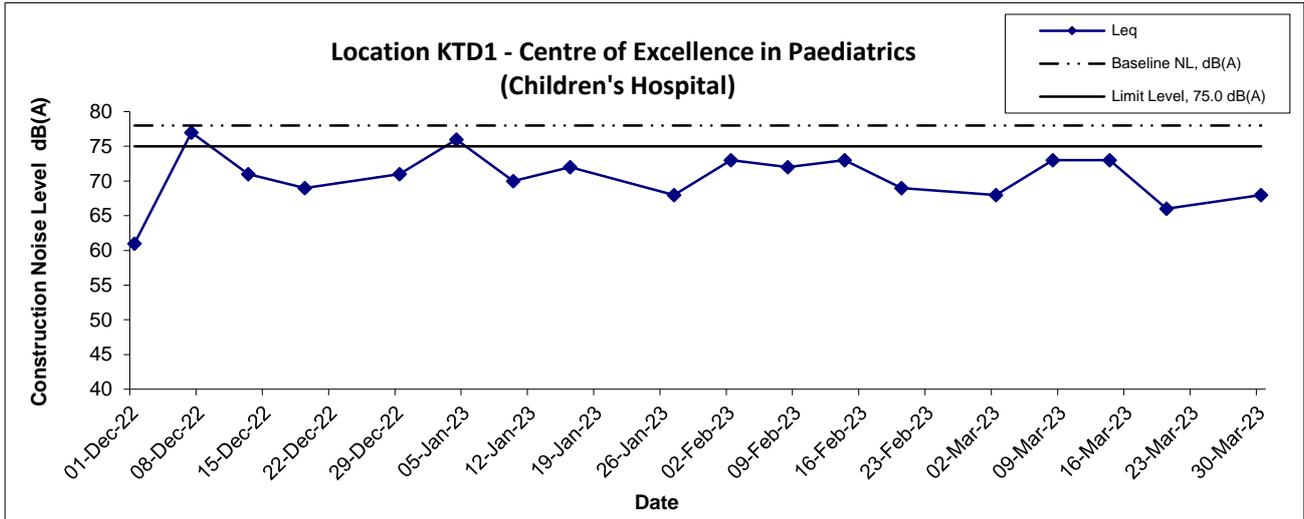
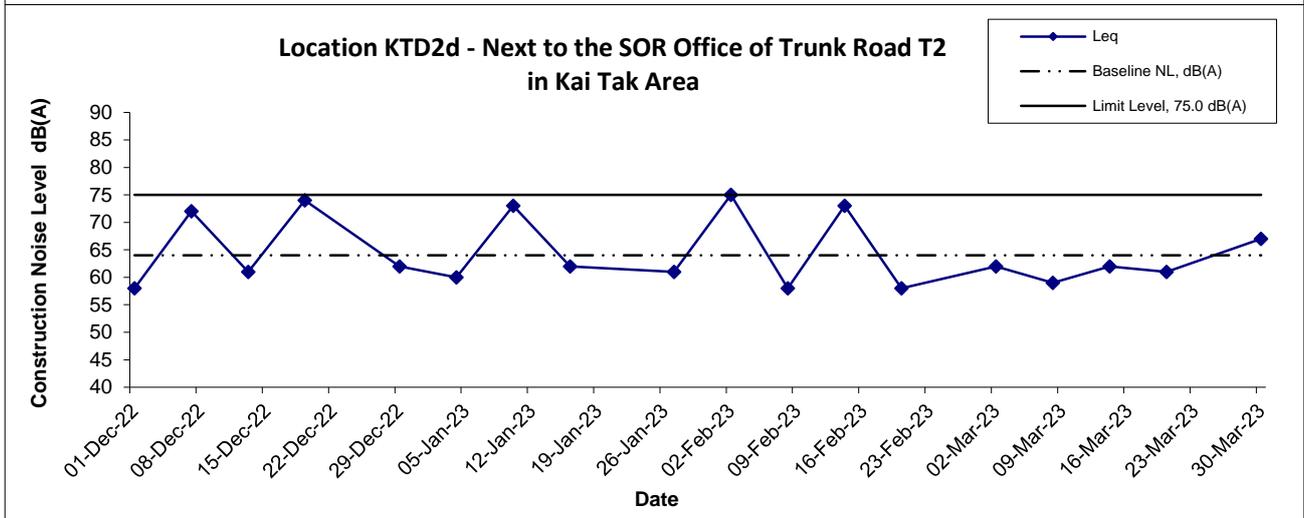
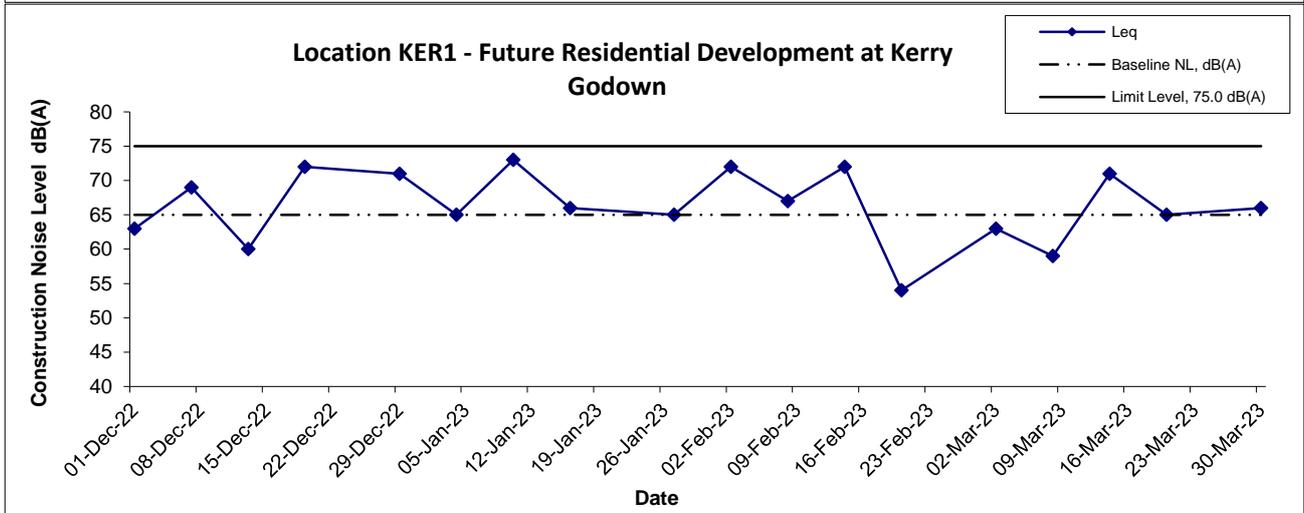
Noise Levels

Title Kai Tak Development – Trunk Road T2 and Infrastructure Works at the Former South Apron Graphical Presentation of Construction Noise Monitoring Results	Date	Project	CINOTECH
	Mar 23	No. MA20003	
		Appendix H

Title Kai Tak Development – Trunk Road T2 and Infrastructure Works at the Former South Apron Graphical Presentation of Construction Noise Monitoring Results	Date Mar 23	Project No. MA20003	
		Appendix H

- 3.10 Impact noise monitoring was conducted at five monitoring stations as scheduled. The monitoring schedule is shown in **Appendix B**. One (1) Action and no Limit Level exceedance was recorded for day time construction noise monitoring in the reporting month.
- 3.11 Noise monitoring results and graphical presentations are shown in **Appendix H**.
- 3.12 According to field observations observed in the reporting period, the major noise sources identified at the noise monitoring stations are shown in **Table 3.4**.

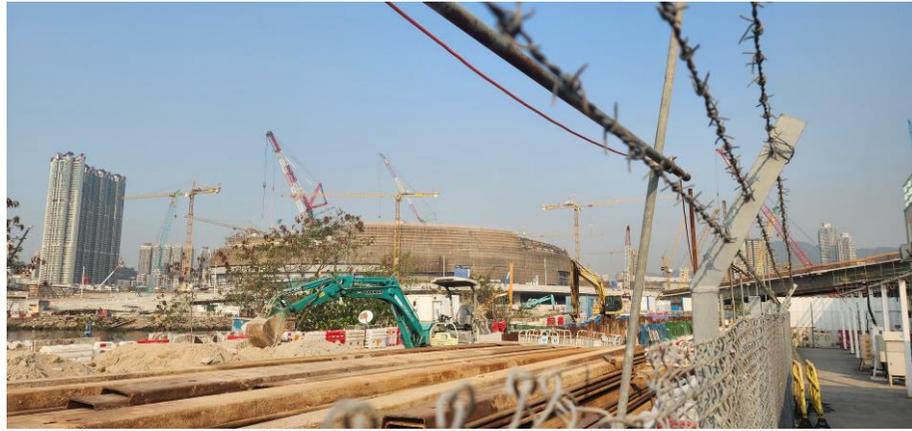
(a) Statement of exceedance(s) 24-hour TSP monitoring measured at KTD2d on 1 March 2023 exceeded the Action level.
(b) Cause of exceedance(s) According to the observation of our field staff, the major dust source(s) and/or reason(s) for exceedance identified at KTD2d is/are as follow: 1. It observed that a stockpile of excavated dusty material with impervious sheet was not covered thoroughly from the construction site which did not belong to BTP. (See Photo 1 & 2) 2. Dry weather

1. Watering of the construction areas 12 times per day to reduce dust emissions.
2. Side enclosure and covering of any aggregate or dusty material storage piles to reduce emissions.
3. Open stockpiles shall be avoided or covered.
4. Tarpaulin covering of all dusty vehicle loads transported to, from and between site locations
5. Establishment and use of vehicle wheel and body washing facilities at the exit points of the site.
6. Imposition of speed controls for vehicles on unpaved site roads, 8 km per hour is the recommended limit

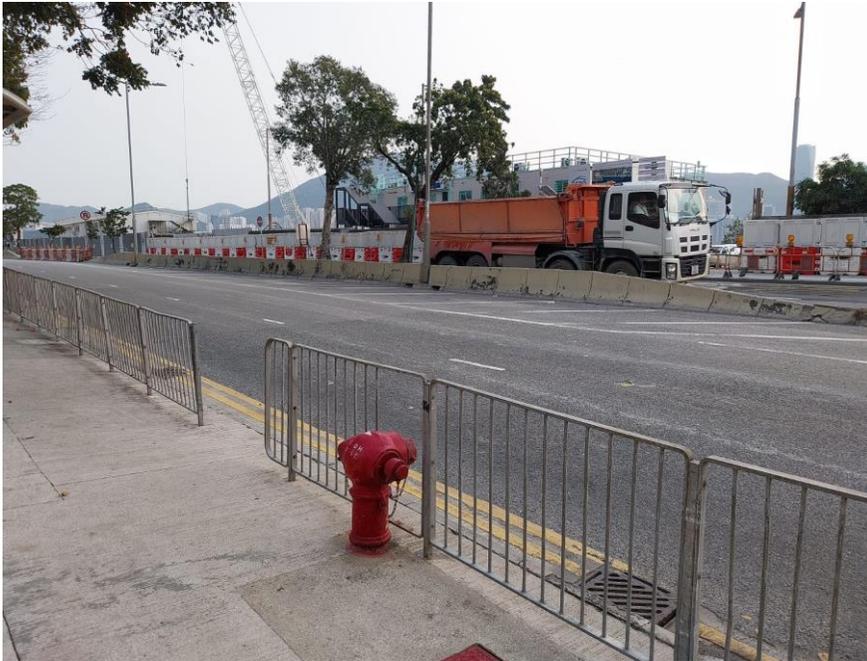
Photo 1

<p>(a) Statement of exceedance(s)</p> <p>24-hour TSP monitoring measured at CKL1 on 1 March 2023 exceeded the action level.</p>
<p>(b) Cause of exceedance(s)</p> <p>According to the observation of our field staff and the information provided by ER and Contractor, the Investigation result for exceedance identified at CKL1 is/are as follow:</p> <ol style="list-style-type: none"> 1. Fluctuation of road traffic along the Cha Kwo Ling Road, a numerous of dump trucks and concrete mixer lorries passed by and raise the dust to the surrounding (Photo 1 & 2). 2. No major project related construction activities was observed during monitoring at CKL1.

1. Watering of the construction areas 12 times per day to reduce dust emissions.
2. Side enclosure and covering of any aggregate or dusty material storage piles to reduce emissions.
3. Open stockpiles shall be avoided or covered.
4. Tarpaulin covering of all dusty vehicle loads transported to, from and between site locations.
5. Establishment and use of vehicle wheel and body washing facilities at the exit points of the site.
6. Imposition of speed controls for vehicles on unpaved site roads, 8 km per hour is the recommended limit.
7. Use of regular watering to reduce dust emissions from exposed site surfaces and unpaved roads, particularly during dry weather.

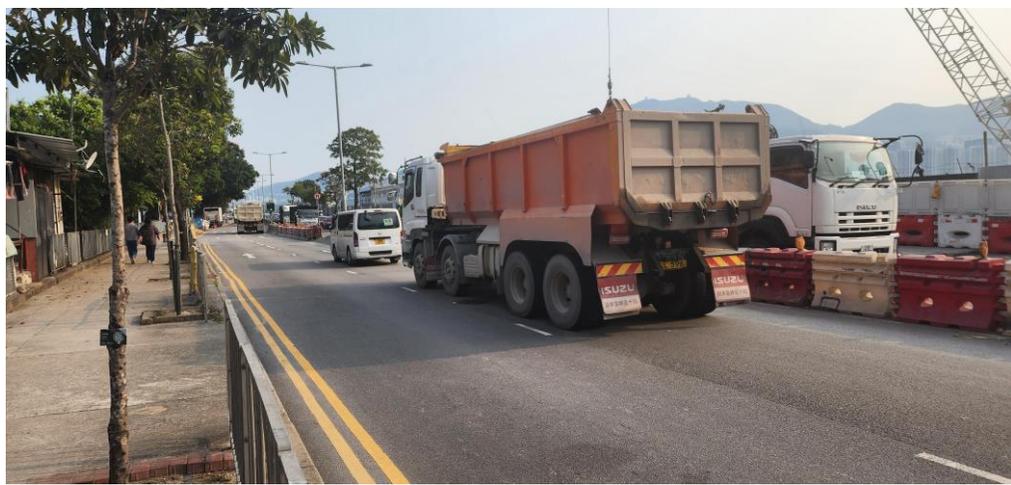
Photo 1

<p>(a) Statement of exceedance(s)</p> <p>24-hour TSP monitoring measured at CKL2 on 1 March 2023 exceeded the limit level.</p>
<p>(b) Cause of exceedance(s)</p> <p>According to the observation of our field staff and the information provided by ER and Contractor, the Investigation result for exceedance identified at CKL2 is/are as follow:</p> <ol style="list-style-type: none"> 1. Fluctuation of road traffic along the Cha Kwo Ling Road, a numerous of dump trucks and concrete mixer lorries passed by and raise the dust to the surrounding (Photo 1 & 2). 2. No major project related construction activities was observed during monitoring at CKL2.
