# Civil Engineering and Development Department

## Trunk Road T2 Monthly Environmental Monitoring and Audit Report (under EP-451/2013) August 2022 (Version 1.0)

**Re: Agreement No. EDO 01/2019  
Independent Environmental Checker for  
Contract No. ED/2018/04 – Trunk Road T2 and Infrastructure Works for  
Developments at the Former South Apron**

**Monthly EM&A Report (August 2022) for EP-451/2013**

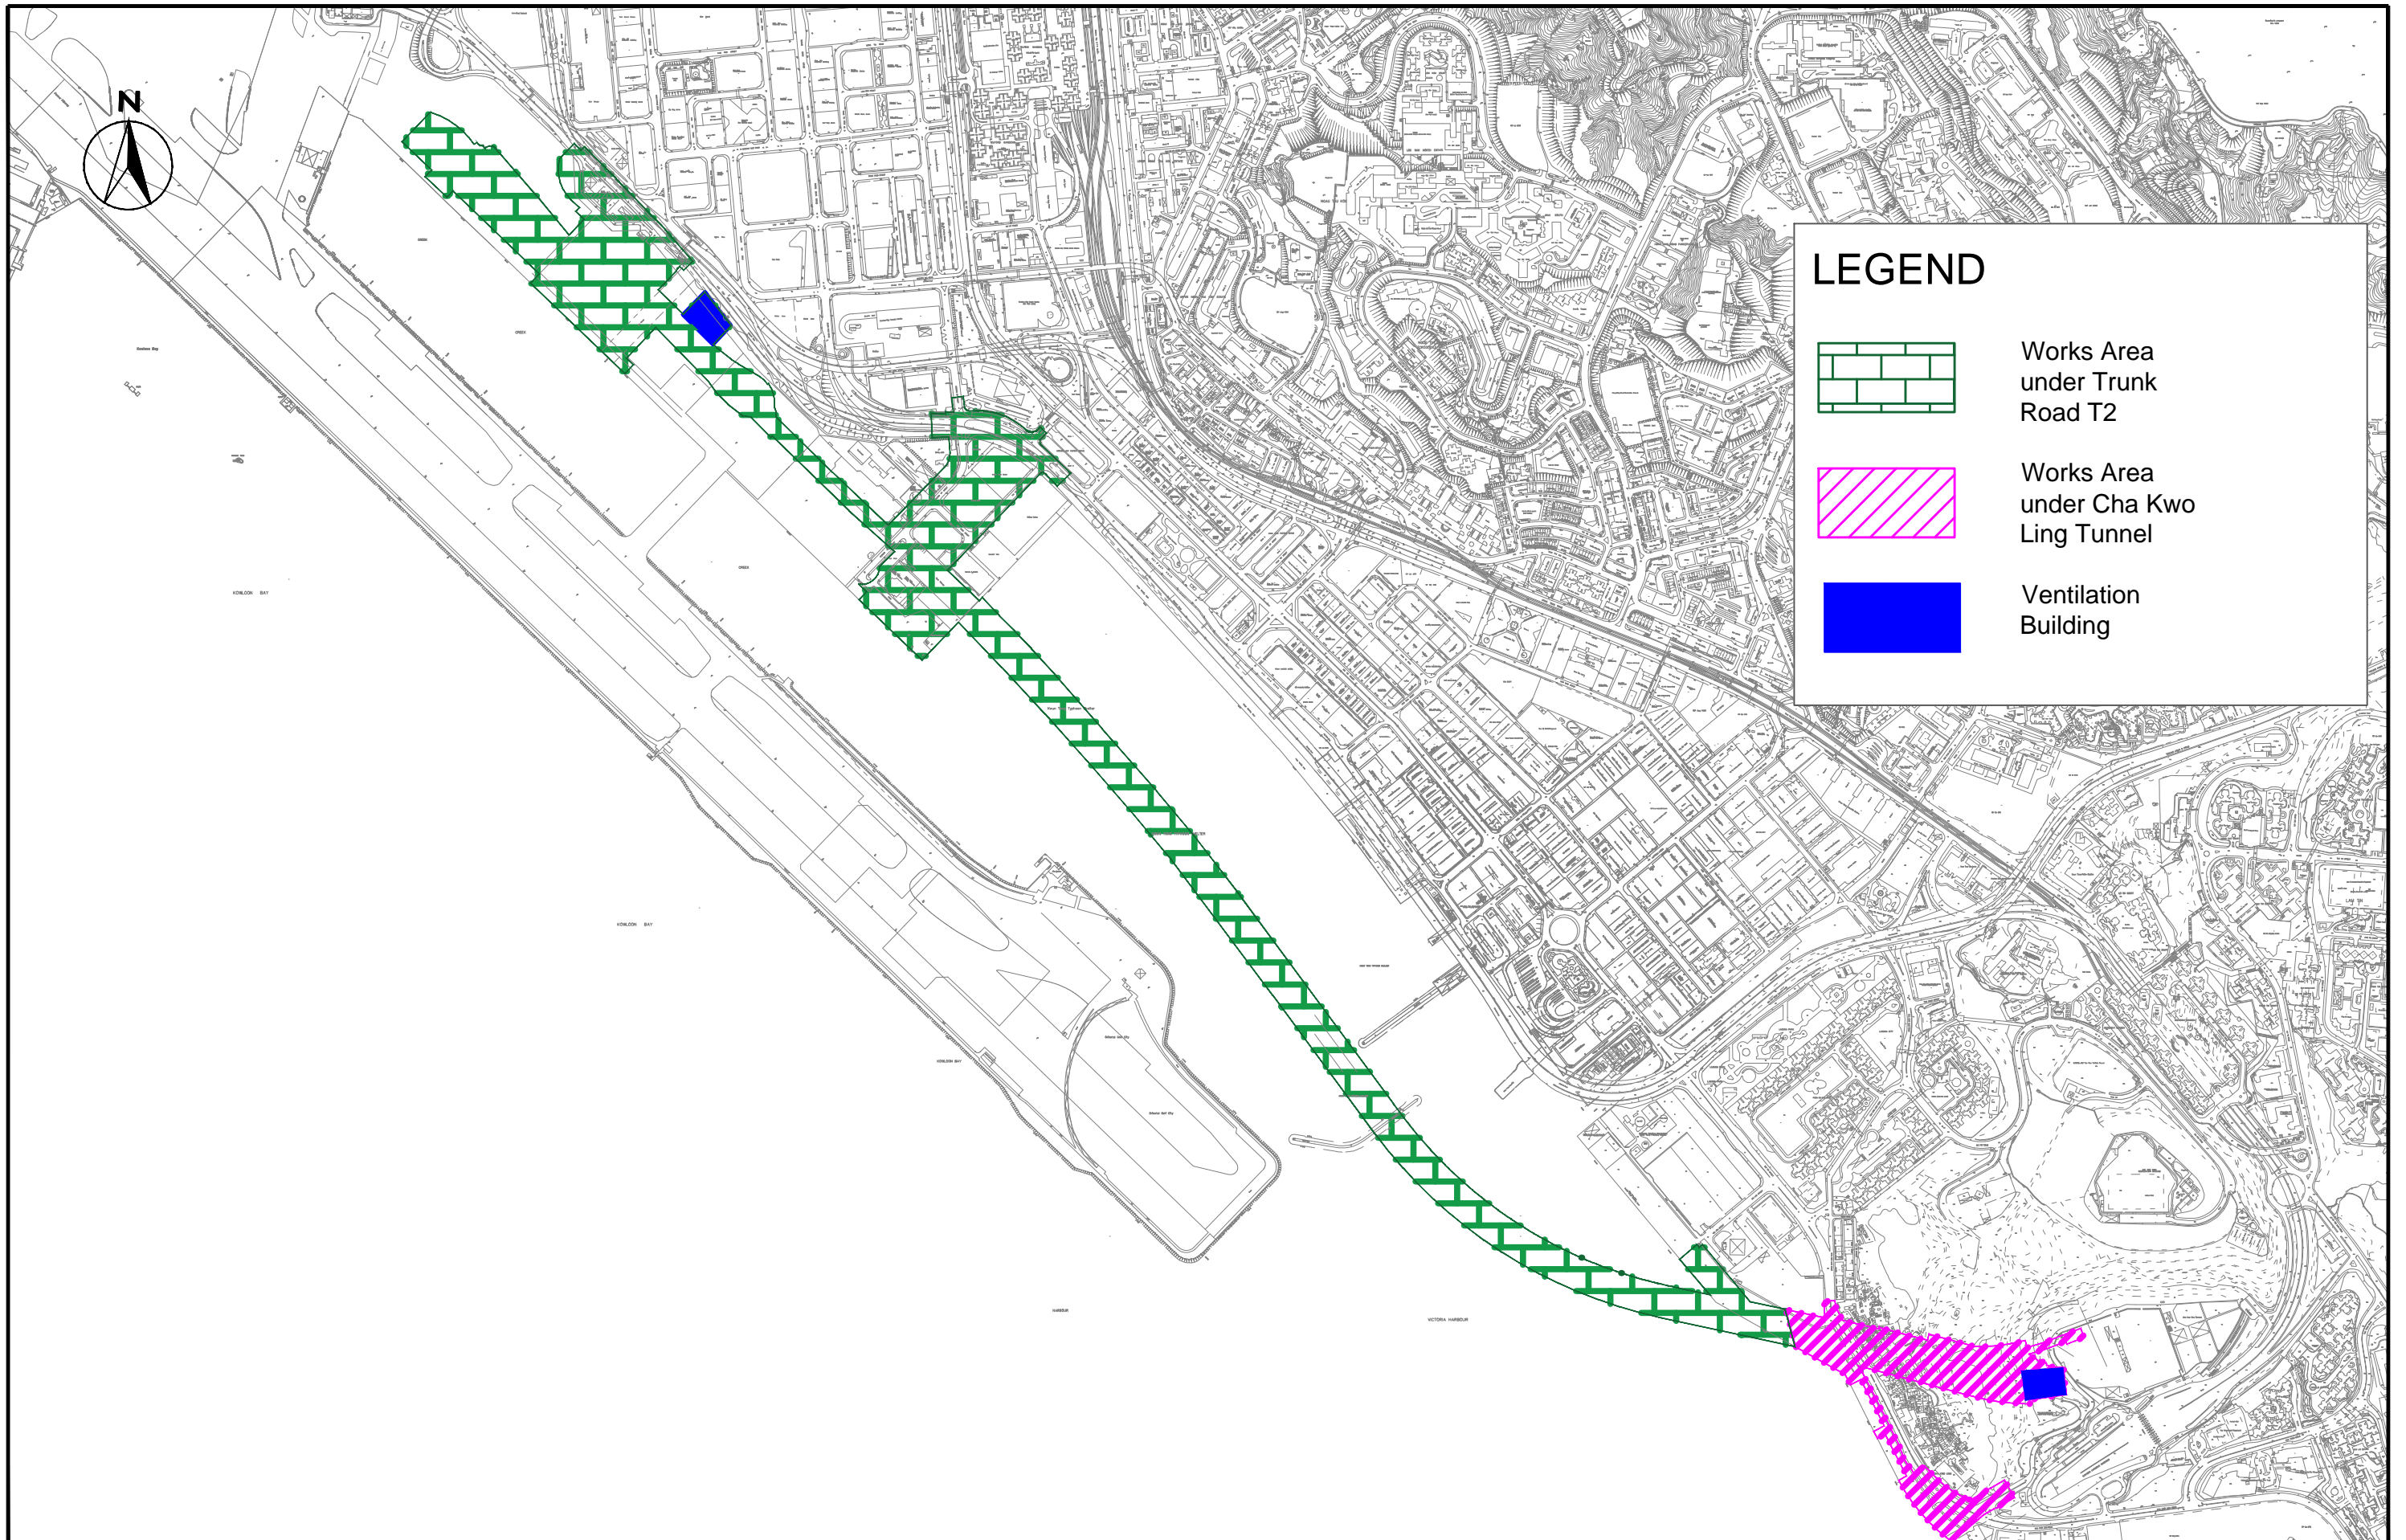
SCALE	1:10000@A3	DATE	March 20
CHECK	KC	DRAWN	TL
JOB No.	MA20003	FIGURE No.	Fig 1
		REV	-

Works Area under Trunk Road T2
-   Works Area under Cha Kwo Ling Tunnel
-   Ventilation Building

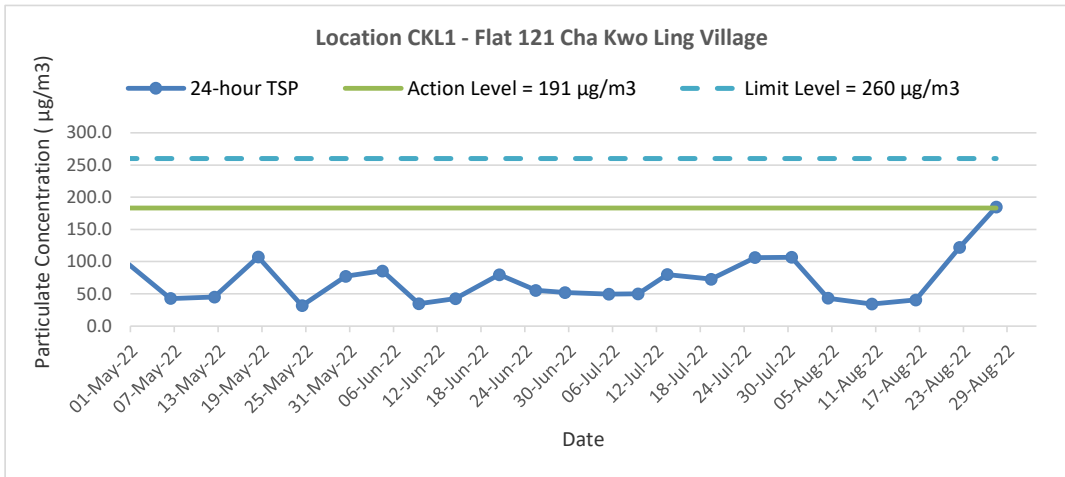
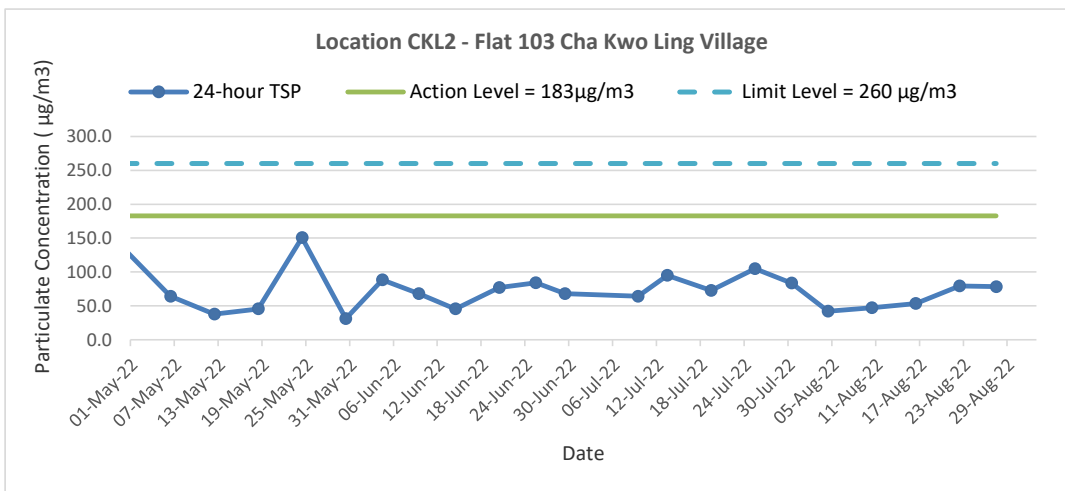
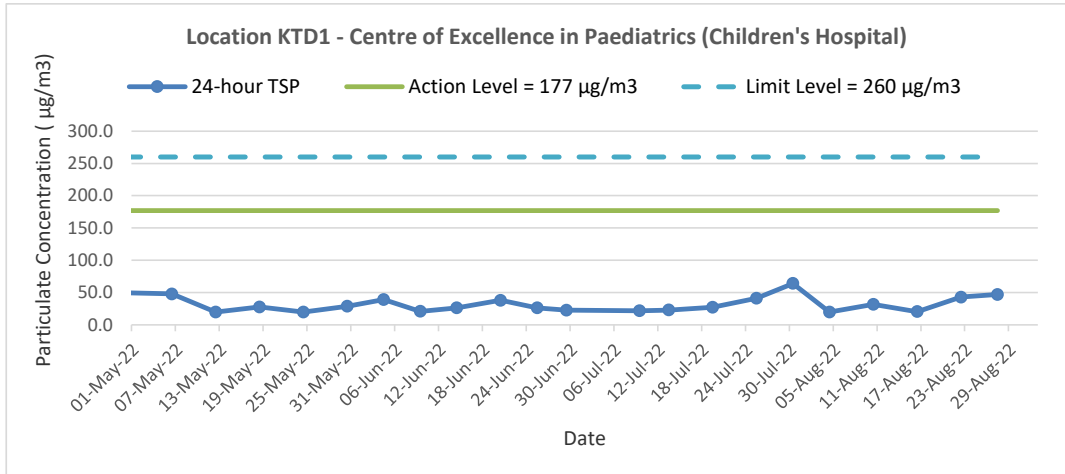
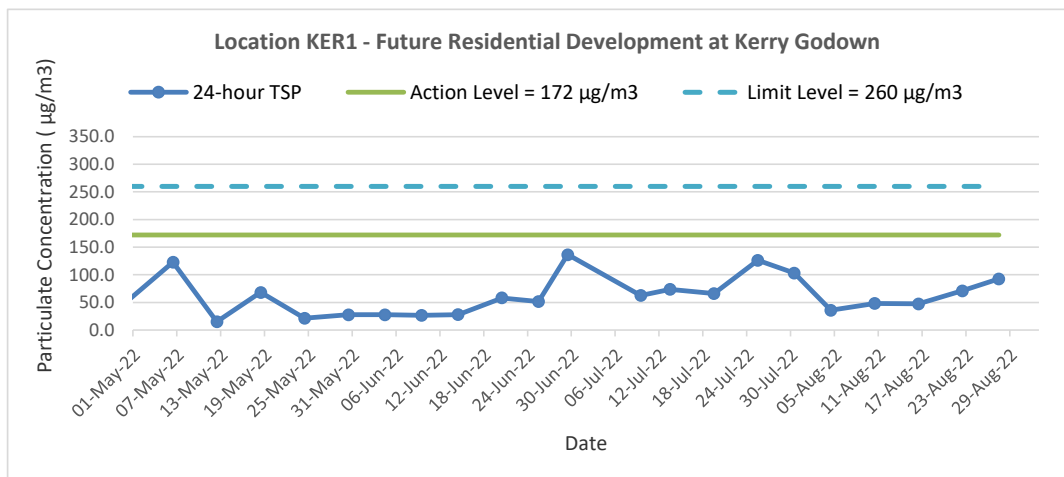
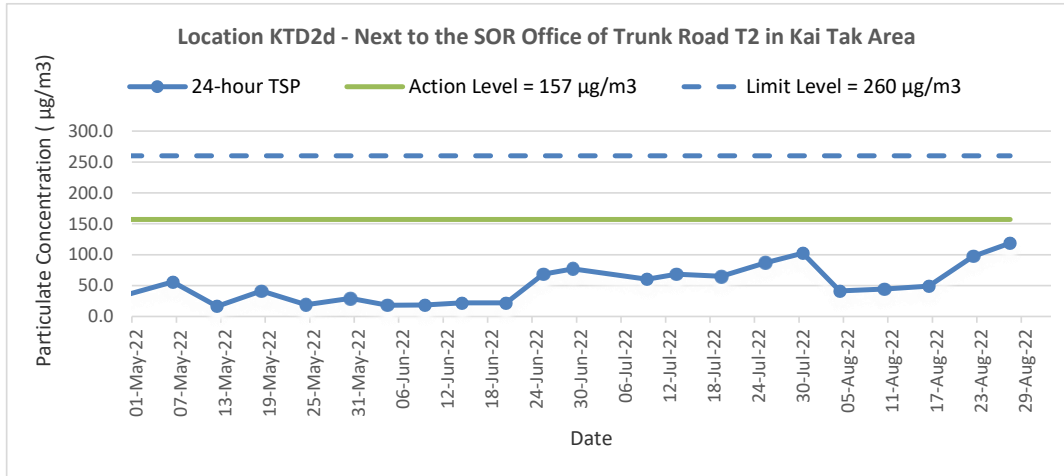
Title Trunk Road T2 and Infrastructure Works for Developments at the Former South Apron  Graphical Presentation of 24-hour TSP Monitoring Results	Date Aug-22	Project No. MA20003	
		Appendix F

Title Trunk Road T2 and Infrastructure Works for Developments at the Former South Apron  Graphical Presentation of 24-hour TSP Monitoring Results	Date Aug-22	Project No. MA20003	
	Appendix F

Title Trunk Road T2 and Infrastructure Works for Developments at the Former South Apron  Graphical Presentation of 24-hour TSP Monitoring Results	Date Aug-22	Project No. MA20003	CINOTECH
		Appendix F

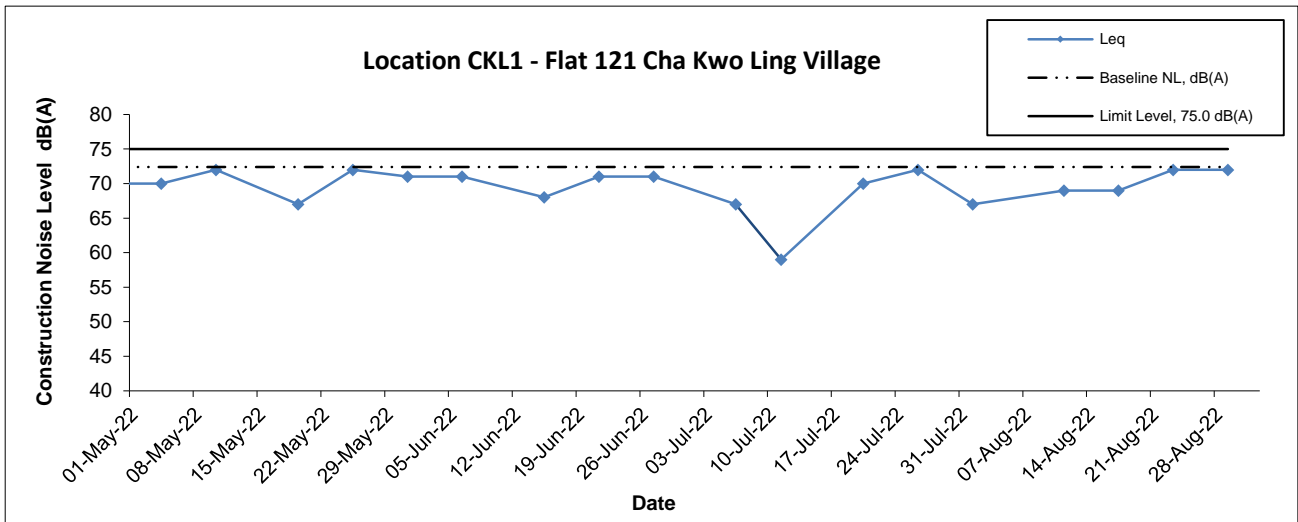
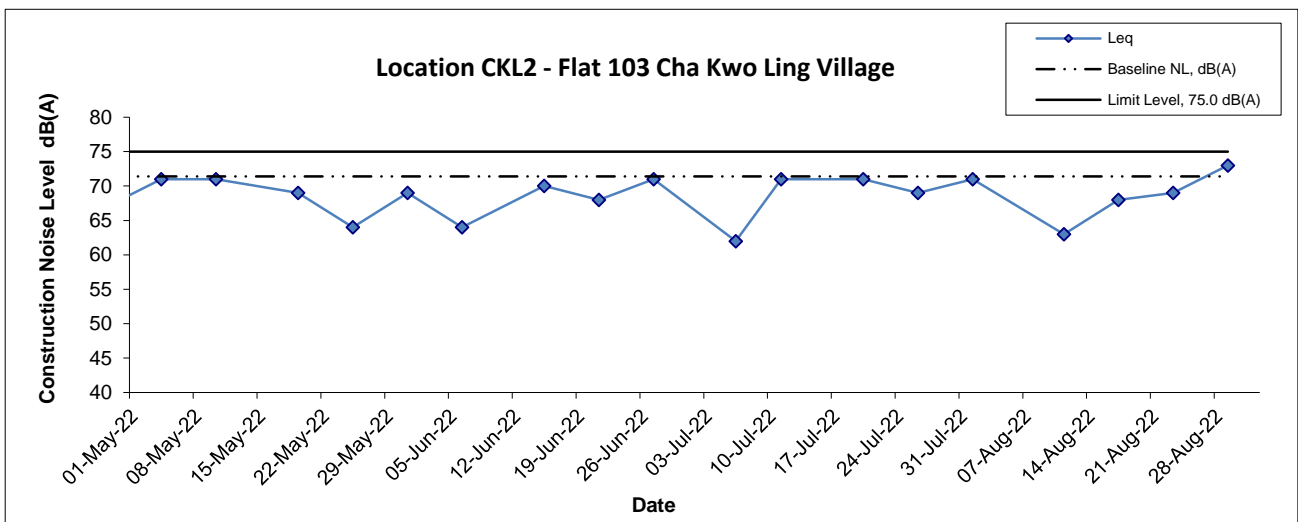
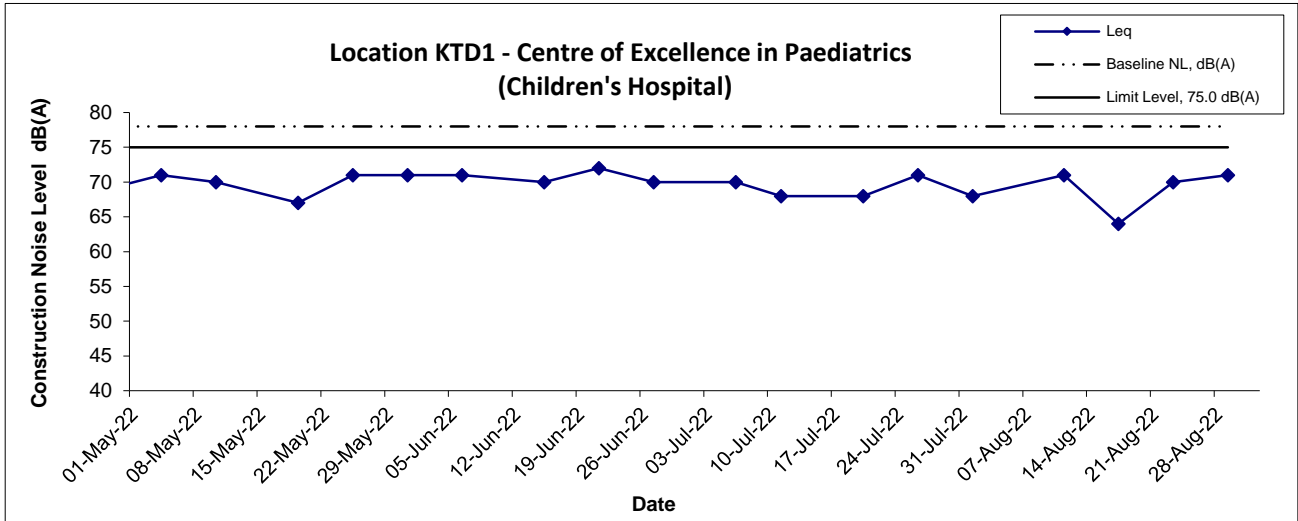
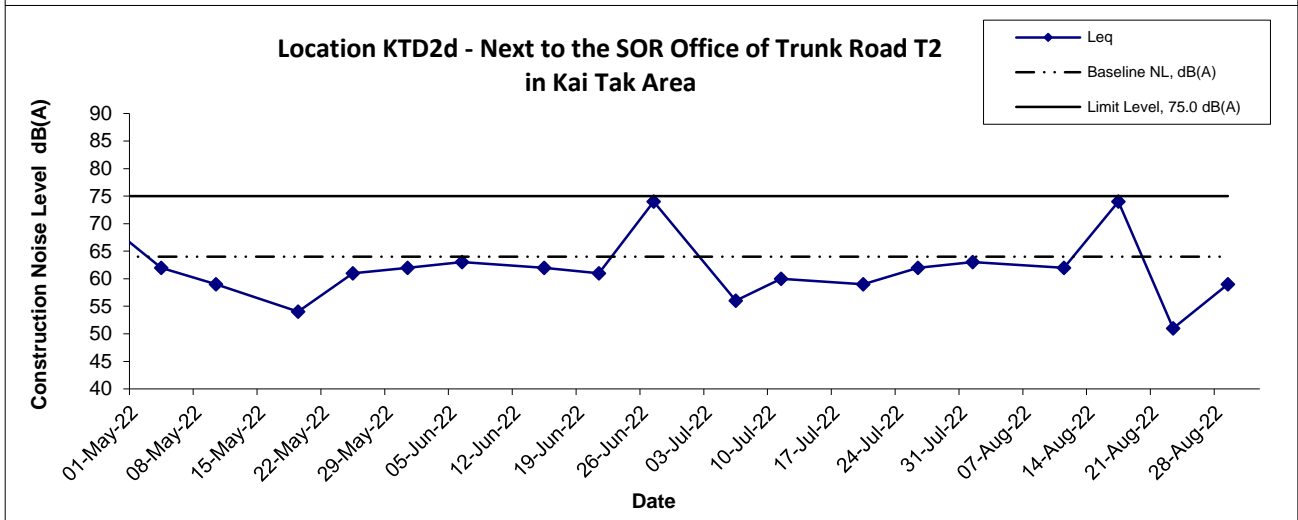
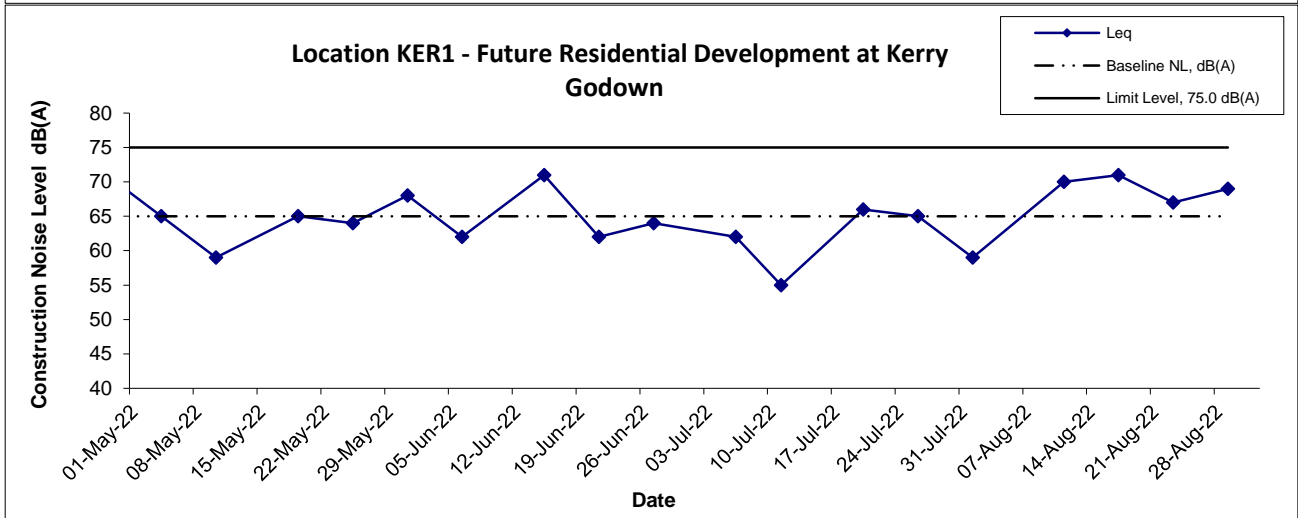
Title Kai Tak Development – Trunk Road T2 and Infrastructure Works at the Former South Apron  Graphical Presentation of Construction Noise Monitoring Results	Date	Project	CINOTECH
	Aug 22	No. MA20003	
		Appendix H

Title Kai Tak Development – Trunk Road T2 and Infrastructure Works at the Former South Apron  Graphical Presentation of Construction Noise Monitoring Results	Date	Project	CINOTECH
	Aug 22	No. MA20003	
	Appendix	H
