Contract No. ED/2018/04

Trunk Road T2 and Infrastructure Works for Developments at the Former South Apron

Appendix N – Summary of Exceedance

NOE No. 220929_24hrTSP (AM1) **Exceedance Level: Action**

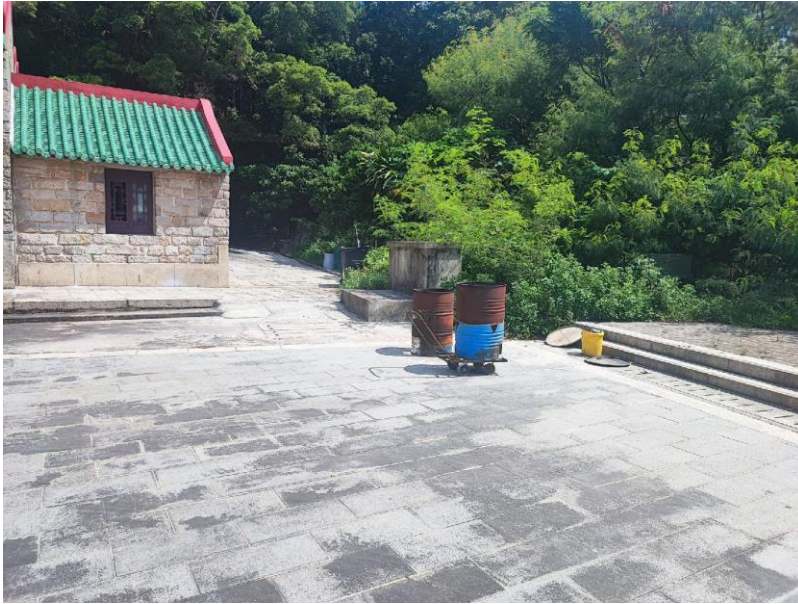
<p>(a) Statement of exceedance(s) 24-hour TSP monitoring measured at AM1 on 29 September 2022 exceeded the action level.</p>
<p>(b) Cause of exceedance(s) According to the observation of our field staff, the major dust source(s) and/or reason(s) for exceedance identified at AM1 is/are as follow:</p> <ol style="list-style-type: none"> 1. According to our field observation, the joss paper furnace was found next to the high volume sampler (HVS), which may affect the result if incense burning was conducted. 2. Non-project related construction works (TKOLTT project) 3. Road traffic along Cha Kwo Ling Road 4. RE and Contractor have confirmed that no construction activity was carried out in the vicinity of the Tin Hau Temple on 29-30 September 2022 under this contract.

Photo 1 – The joss paper furnace was found next to the high volume sampler (HVS) at AM1.
(Taken on 5 Oct 2022)

Based on the finding(s) and observation(s) above, we deduce Action Level exceedance of 24-hour TSP recorded at station AM1 on 29 September 2022 respectively are due to the non-project related influence. Therefore, the exceedance is considered as **non-project related**.

Although the exceedance is consider as non-project related, it is recommended that the following construction dust mitigation measures shall always to be implemented on site to reduce/ minimize the generation of dust due to the construction activities.

1. Watering of the construction areas 12 times per day to reduce dust emissions.
2. Side enclosure and covering of any aggregate or dusty material storage piles to reduce emissions.
3. Open stockpiles shall be avoided or covered.
4. Tarpaulin covering of all dusty vehicle loads transported to, from and between site locations.
5. Establishment and use of vehicle wheel and body washing facilities at the exit points of the site.
6. Imposition of speed controls for vehicles on unpaved site roads, 8 km per hour is the recommended limit.
7. Use of regular watering to reduce dust emissions from exposed site surfaces and unpaved roads, particularly during dry weather.

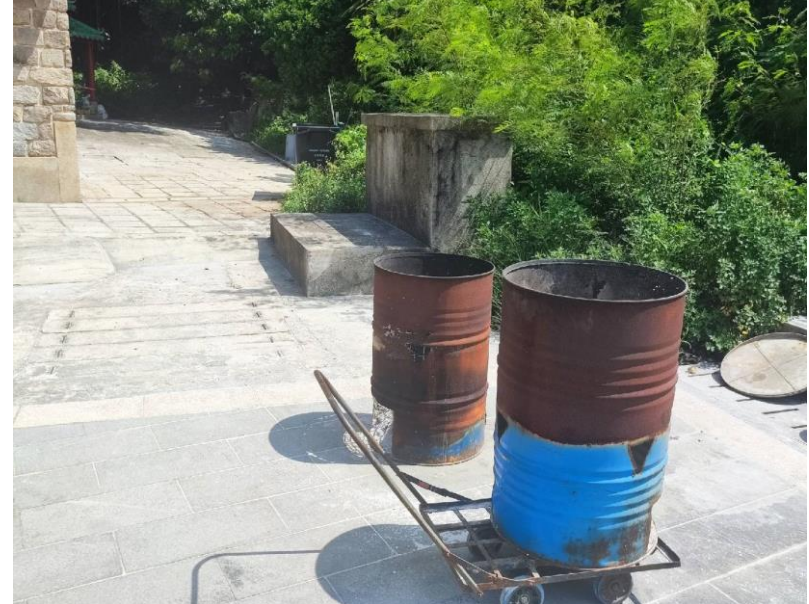
Photo 2 – The joss paper furnace was found next to the high volume sampler (HVS) at AM1.
(Taken on 5 Oct 2022)
